Memorandum by Dr A. F. Anderson CEng FIEE March 2012 : Re the Tanya Spotts EDR results.

In an ODI Report attached at the end of this memo, Mrs Spotts describes a sudden acceleration incident that she experienced on 26th December 2011 in a 2011 Model Year Lexus ES350. See also <http://edition.cnn.com/2012/03/01/us/toyota-memo-acceleration-concerns/> for her interview with CNN.

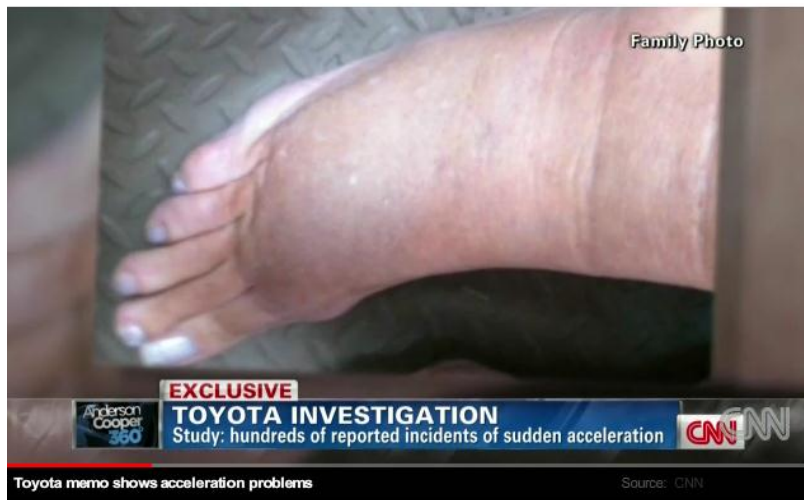
Fig 1 Damage to driver's foot claimed to be caused by hard braking

Fig 1 shows a picture of Mrs Spotts’ foot taken after the accident. As I understand it, her doctor has attributed the sprain to excessive force on braking. I assume that Toyota are claiming either (1) that it is

evidence of Mrs Spotts pressing pedal to metal on the accelerator, imagining it to be the brake, or (2) as evidence of her heavy braking having first made a “pedal error”.

- If (1) then Toyota would have to explain how the injury could be obtained without pressing accelerator pedal to metal, since there is no evidence from the EDR record of the accelerator pedal ever having been depressed to more than 21% of the WOT position.
- If (2) Then Toyota would have to explain how Mrs Spott managed to get her foot off the accelerator pedal and fully depressing the brake pedal in less than 0.4 seconds.

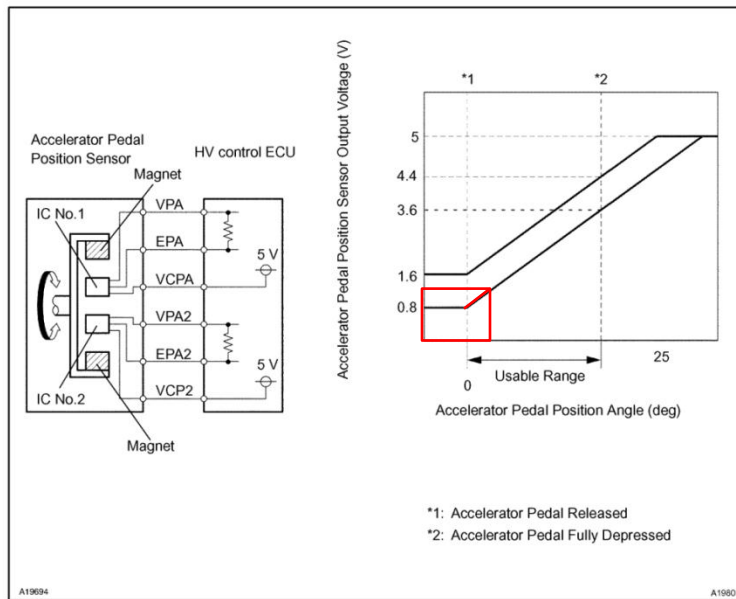
Fig 3 Voltage Output Characteristic for Pedal Sensors A and B

Fig 3 shows the typical voltage characteristics of the two pedal sensors A and B².

- The A sensor (higher characteristic) ranges from 1.6 v to 4.4 v in its usable range, corresponding, respectively, with closed and wide open throttle (WOT)
- The B sensor (lower characteristic) ranges from 0.8 v to 3.6v in its usable range, corresponding, respectively, with closed and wide open throttle (WOT)

The voltages of 0.78v and 1.37 v, minimum and maximum voltages recorded by the EDR are below the usable range of sensor A, but within the usable range of sensor B. Thus it is clear that it is sensor B that has been monitored by the EDR. It would appear that 0.78 corresponds, more or less, with the lower end of the usable range (0.8 v) and represents somewhere near the closed throttle position.
