**REPORT OF DR A F ANDERSON  
INDEPENDENT ELECTRICAL ENGINEERING CONSULTANT  
DATED 9th May 2012**

**Specialist Field : Electrical Engineering**

**Subject Matter : Sudden Acceleration/Surge Incident Brandon Street,  
Wellington NZ Friday 20<sup>th</sup> January 2012**

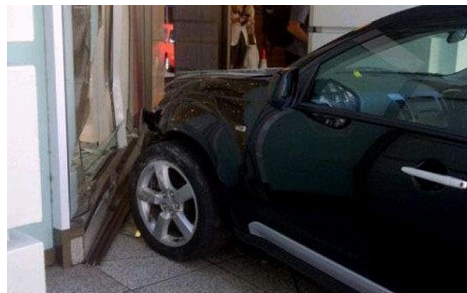
**Fig 8c Damaged window (Press)**

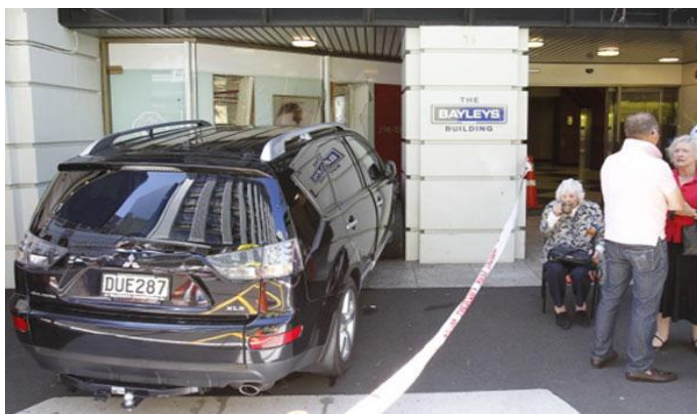
**Fig 8d Vehicle jammed against pillar (Press)**

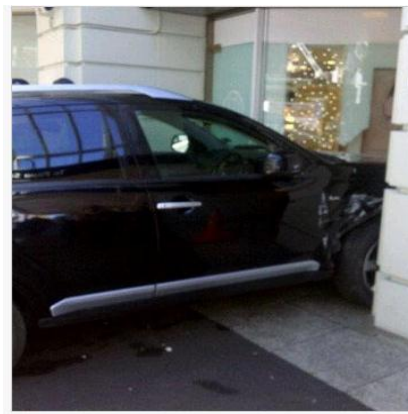
**Fig 8e RH side of vehicle (Press)**

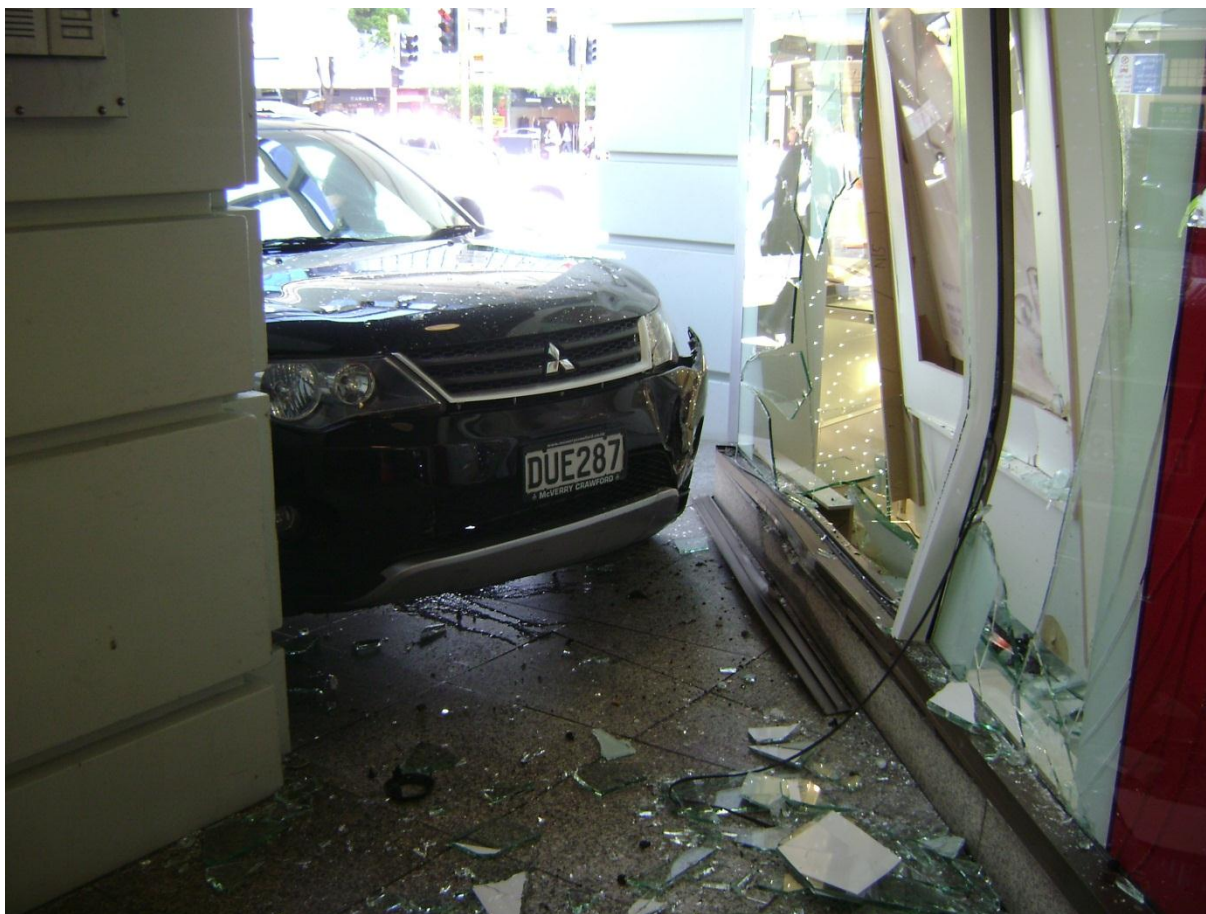
(Police photograph DSC03784JPG)

**Fig 9 Front of vehicle after crash and broken window.**

It is clear that the vehicle must have initially impacted the glass beyond the this point. Presumably the vehicle was pushed back to release the injured pedestrian.

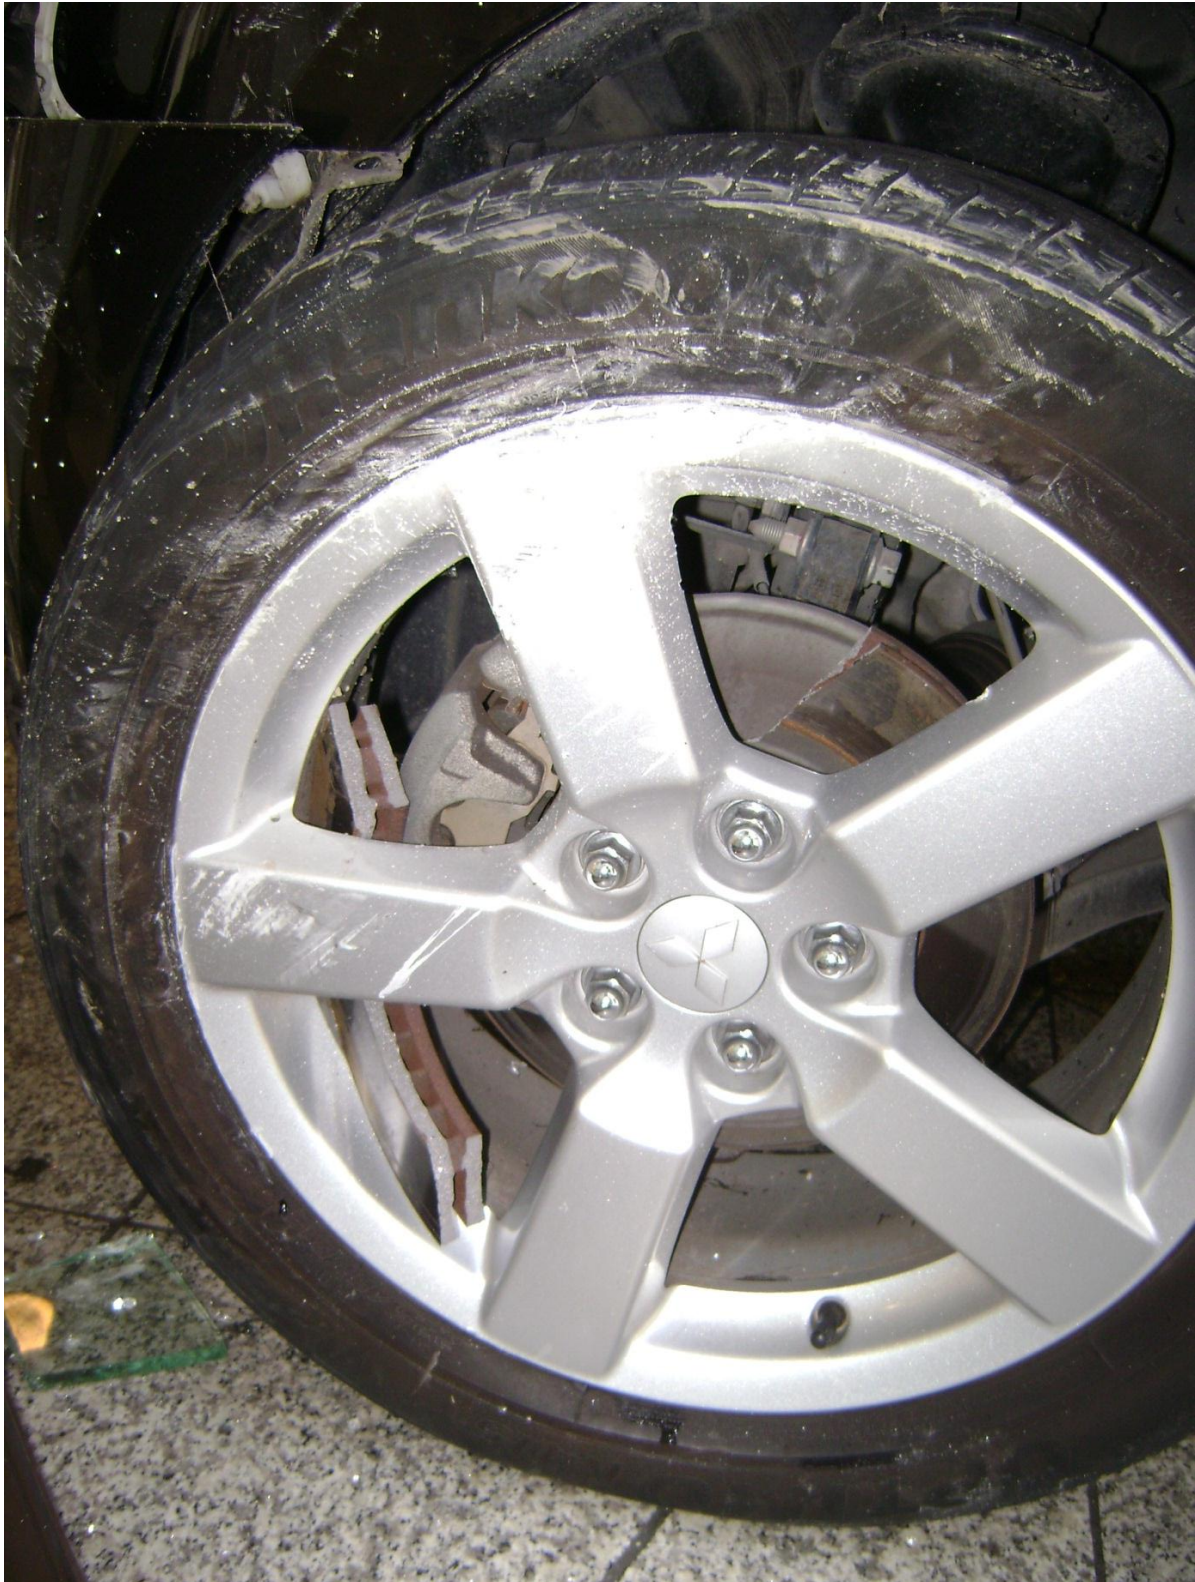
(Police photograph DSC03785PG)

**Fig 10 Nearside front wheel after crash.**

Note THE scuffing on both wheel and tyre and the large segment of fractured and dislodged brake disc. The wheel does not seem to have been permanently distorted by the crash. It is not known if the segment of brake disc was found in this position or was placed there for the photo

Figs 10 and 11 show quite clearly that a large sector of the cast iron brake rotor disc for the L.H. front wheel has fractured and has broken off. The wheel itself does not appear to have more than superficial damage and, from the photographs, would not appear to have greatly been damaged during the incident.

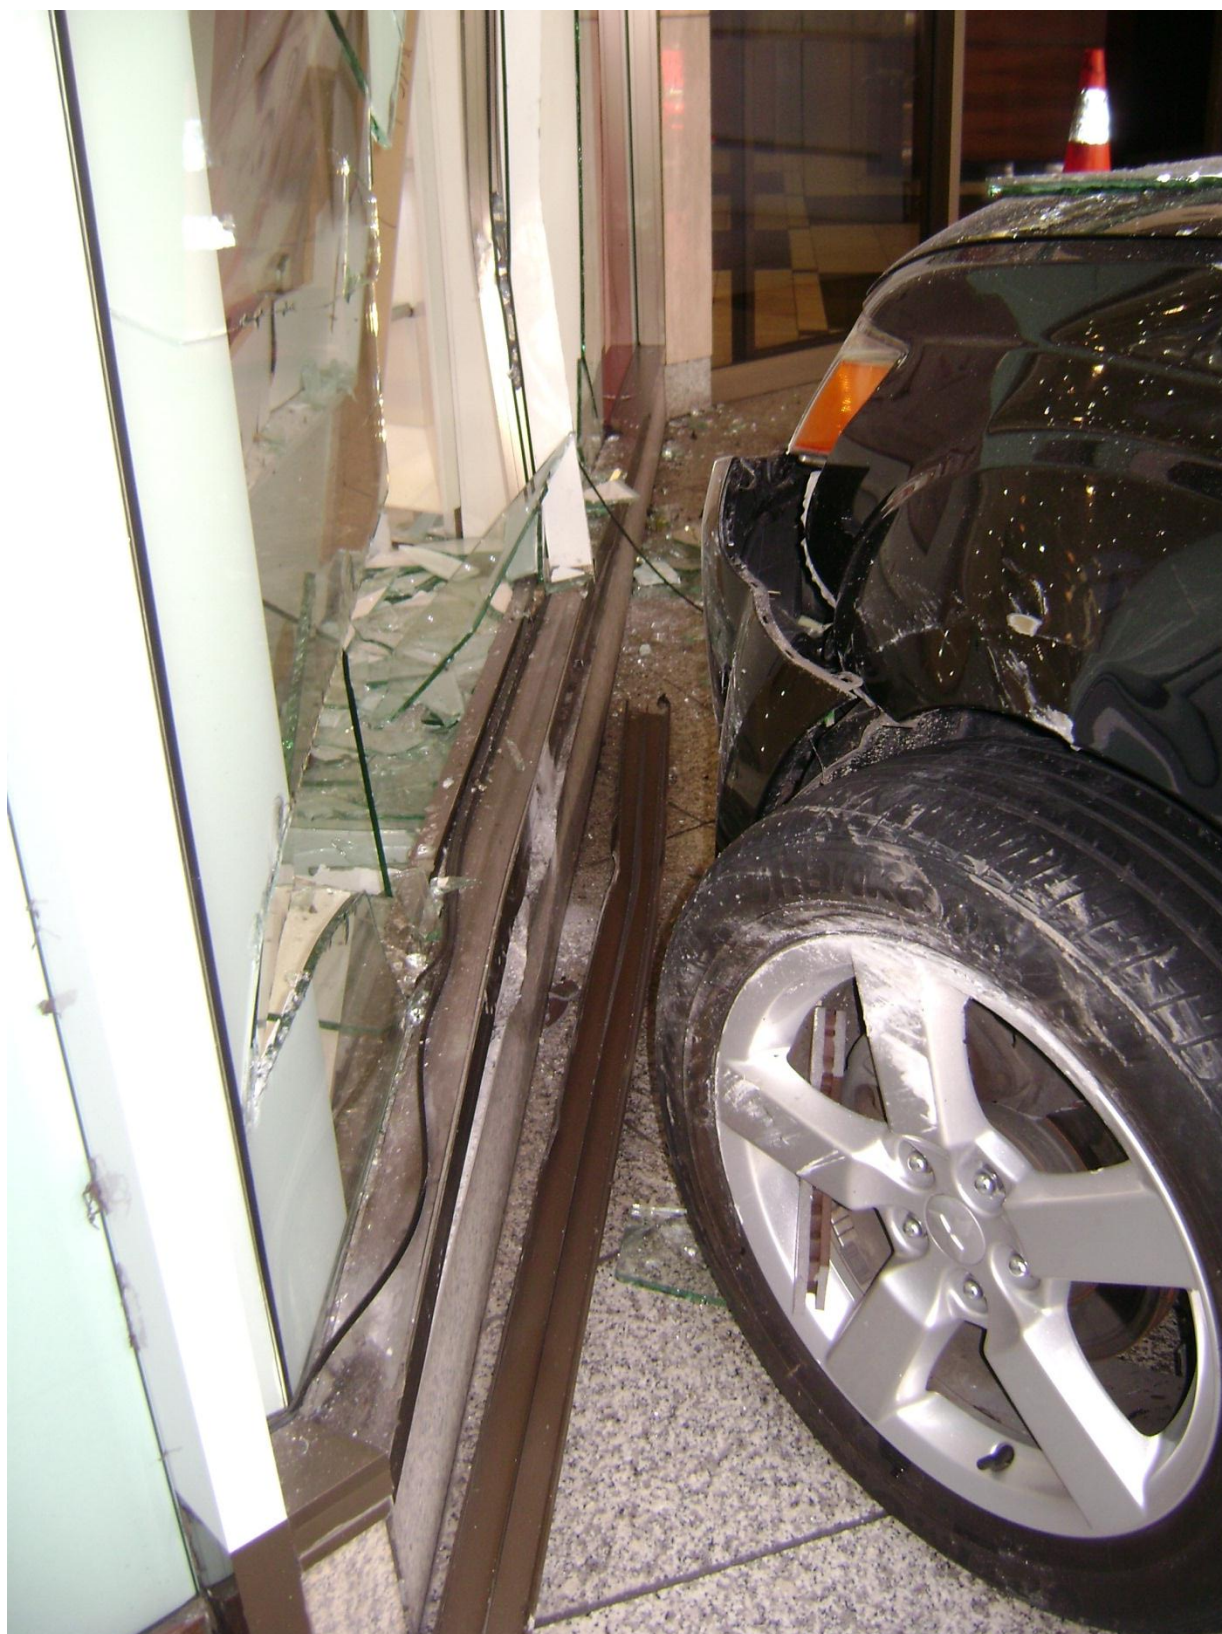
(Police photograph DSC03789.JPG)

**Fig 11 Nearside front wheel after crash.**

Note scuffing on both wheel and tyre and large chunk of fractured and dislodged brake disc.

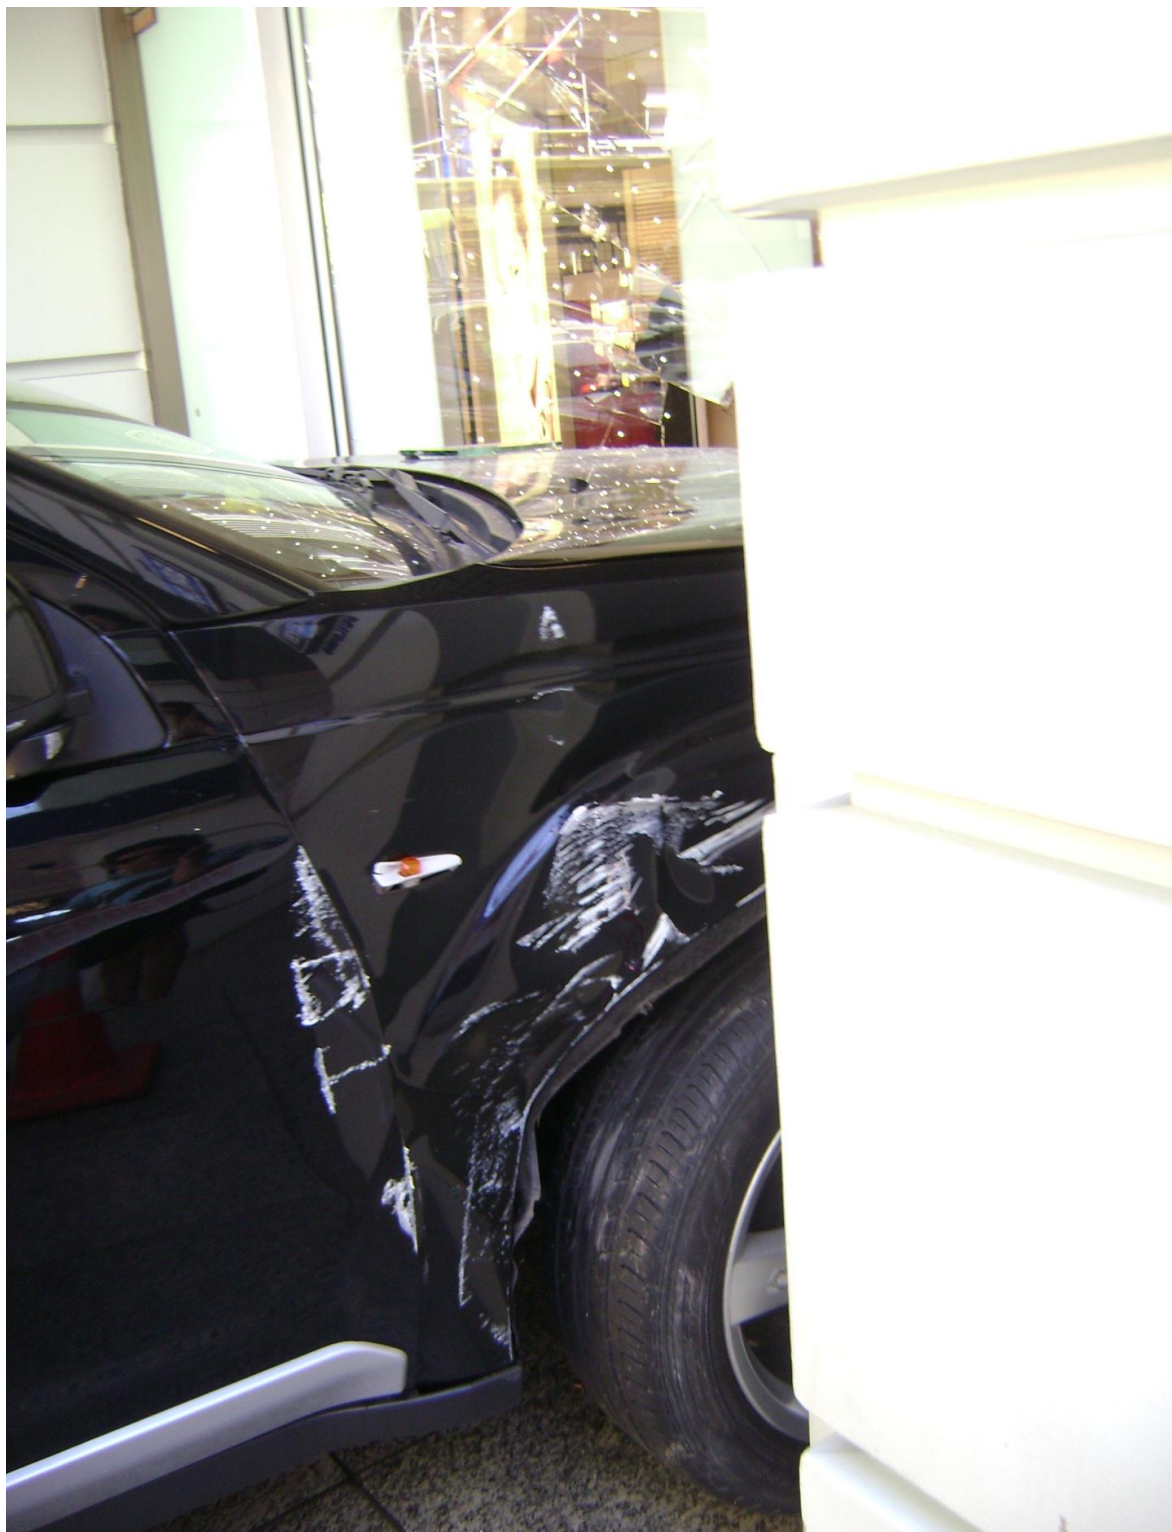
(Police photograph DSC03783.JPG)

**Fig 12 Drivers side showing damage to front right wing and signs of rubbing on road surface and wall of tyre**

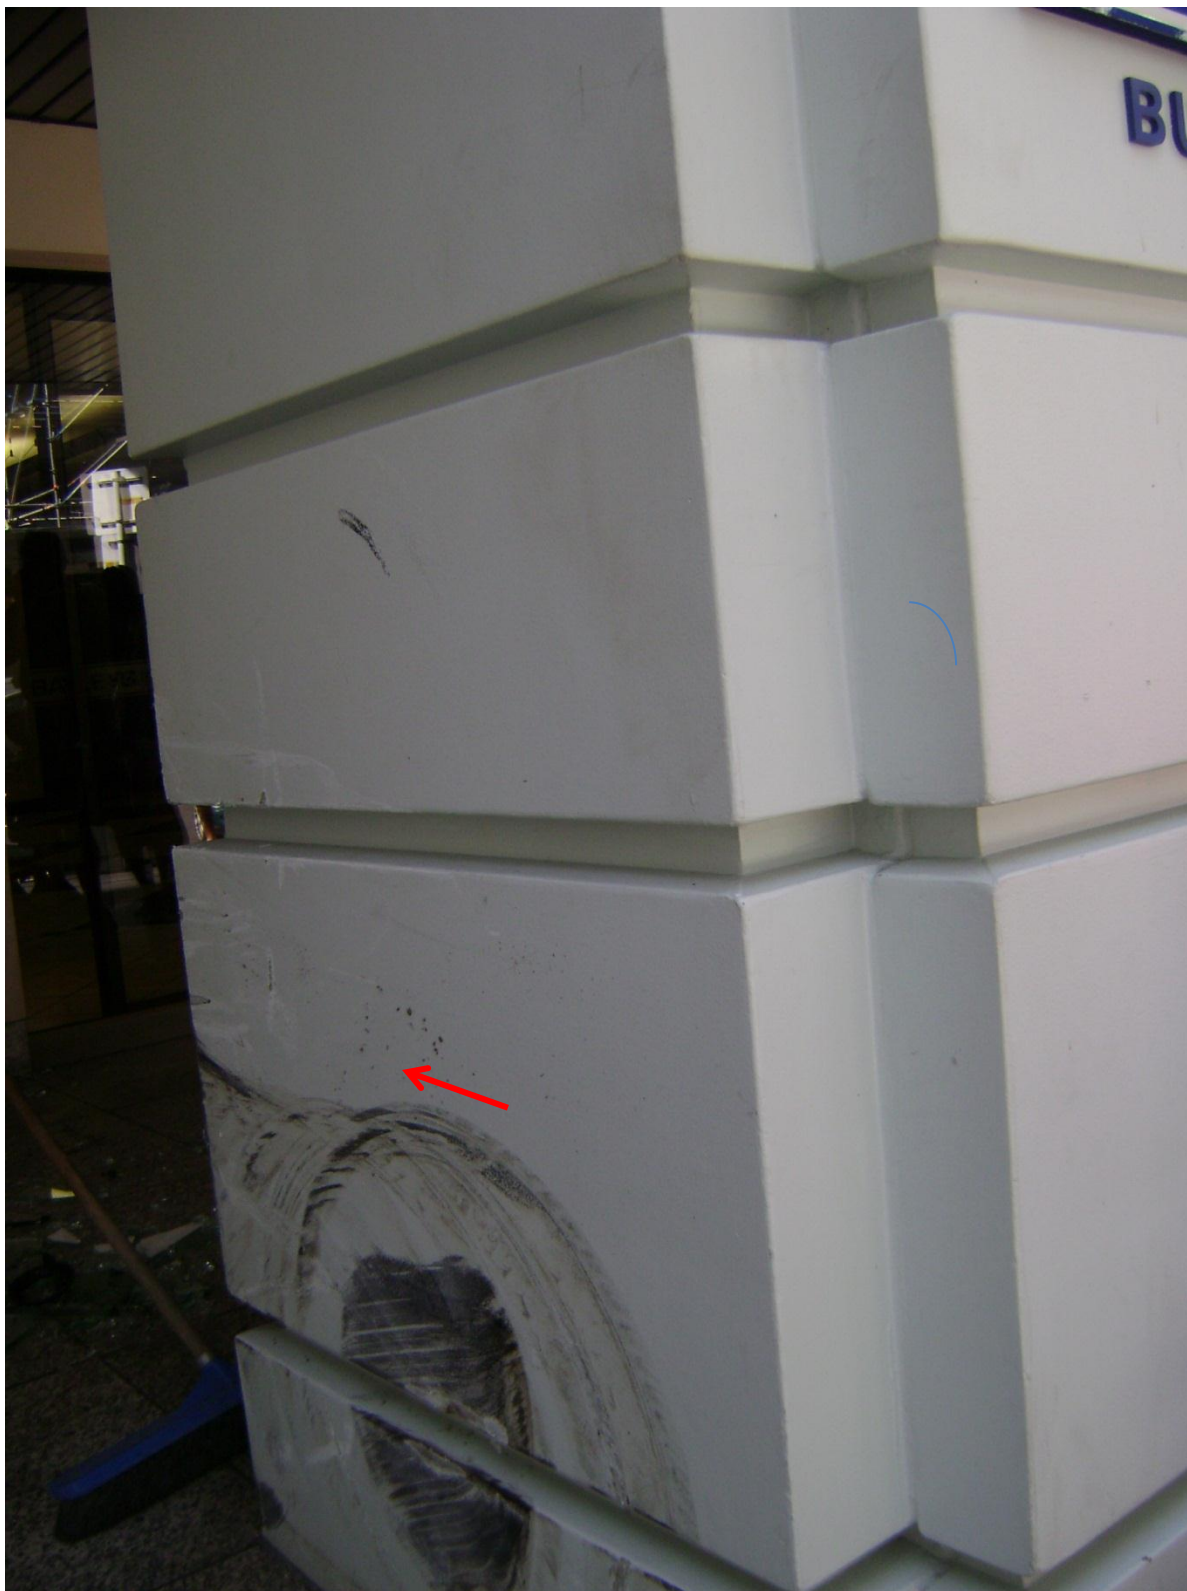
(Police photograph DSC03793JPG)

**Fig 13 Circular scuff marks on pillar that appear to have been caused by rotating RH front tyre.**

Note that the centre of rotation appears to have shifted over time. Red arrow shows presumed direction of rotation of RH front wheel and tyre.

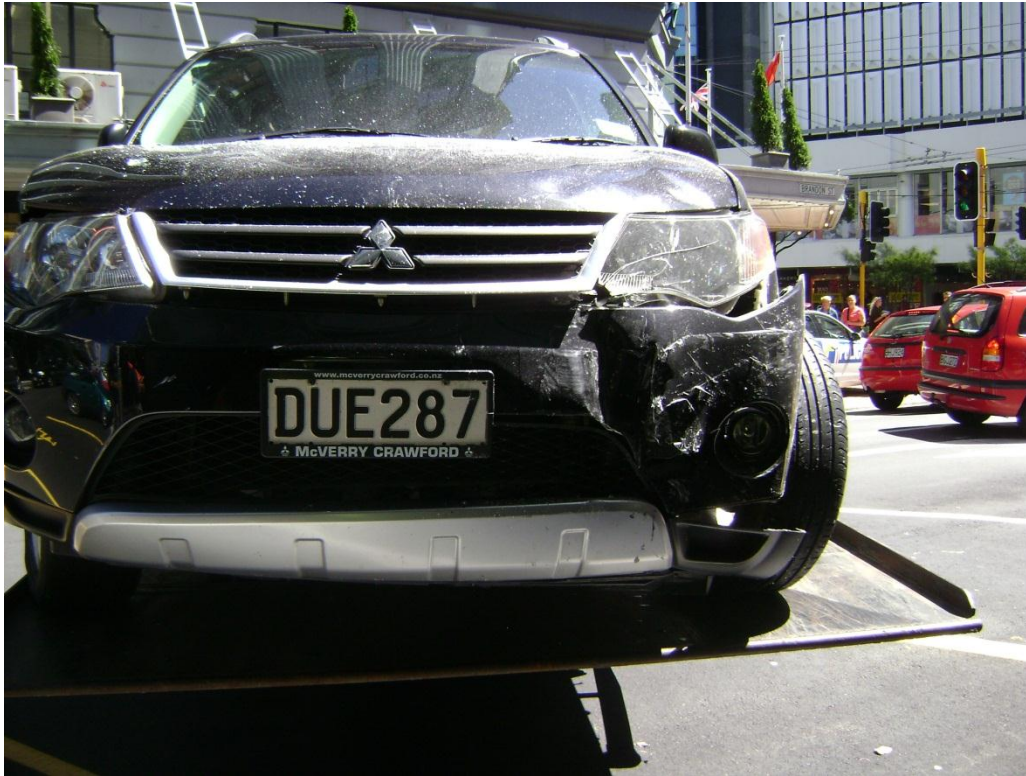
(Police photograph)

**Fig 14 Front of vehicle after removal from crash scene showing that damage is mainly to the wings of the vehicle**

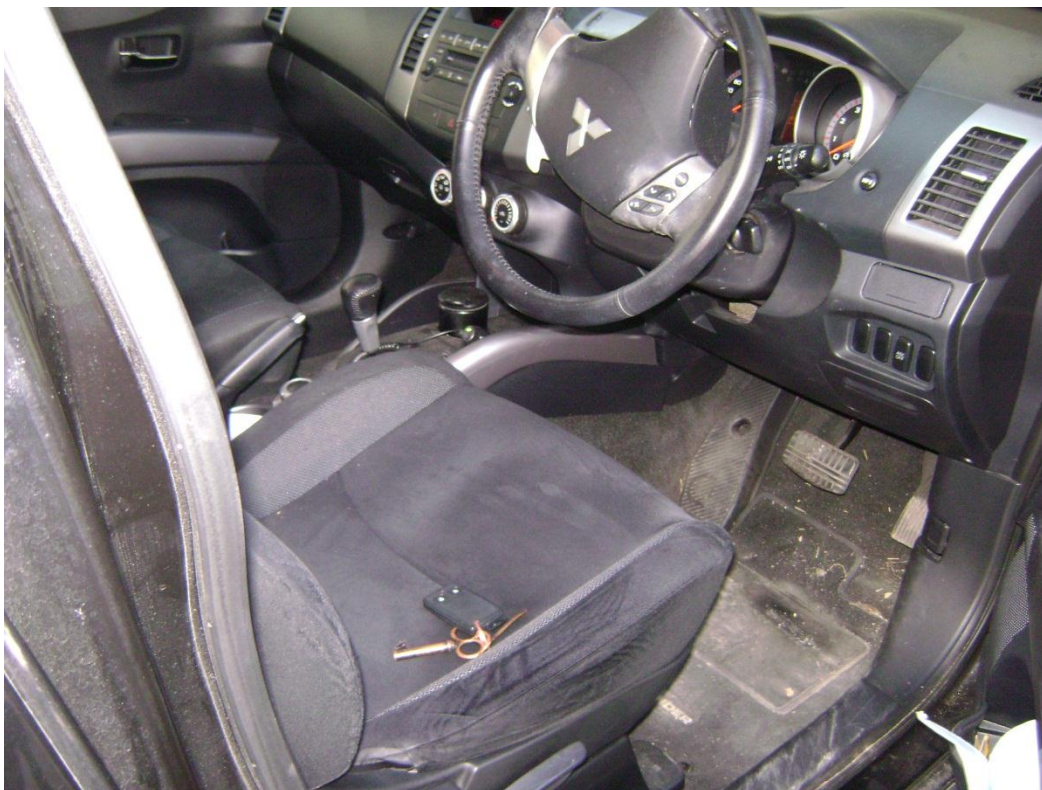
(Police photograph)

**Fig 15 Brake and accelerator pedal arrangement.**

The brake and accelerator pedals appear to be spaced well apart.

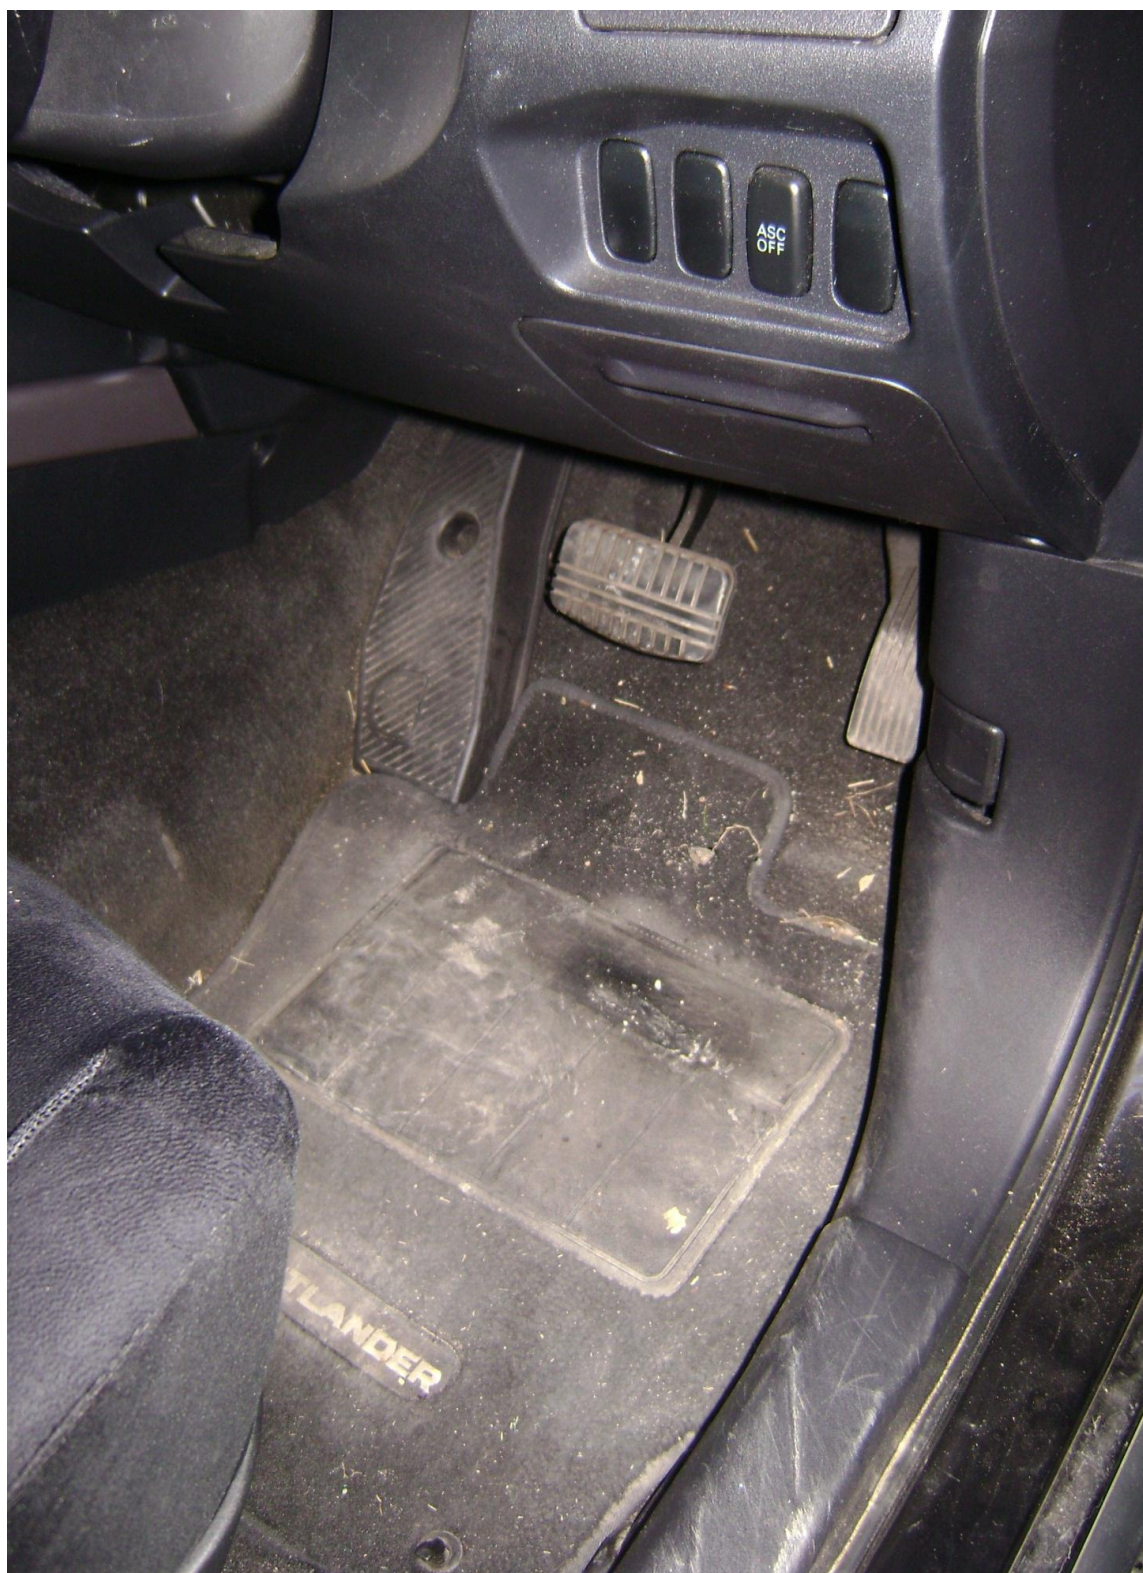
(Police photograph)

**Fig 16 Brake and Accelerator pedal arrangement. Most of the heel wear on the floor mat seems more or less in the middle of the mat. (Police photograph)**

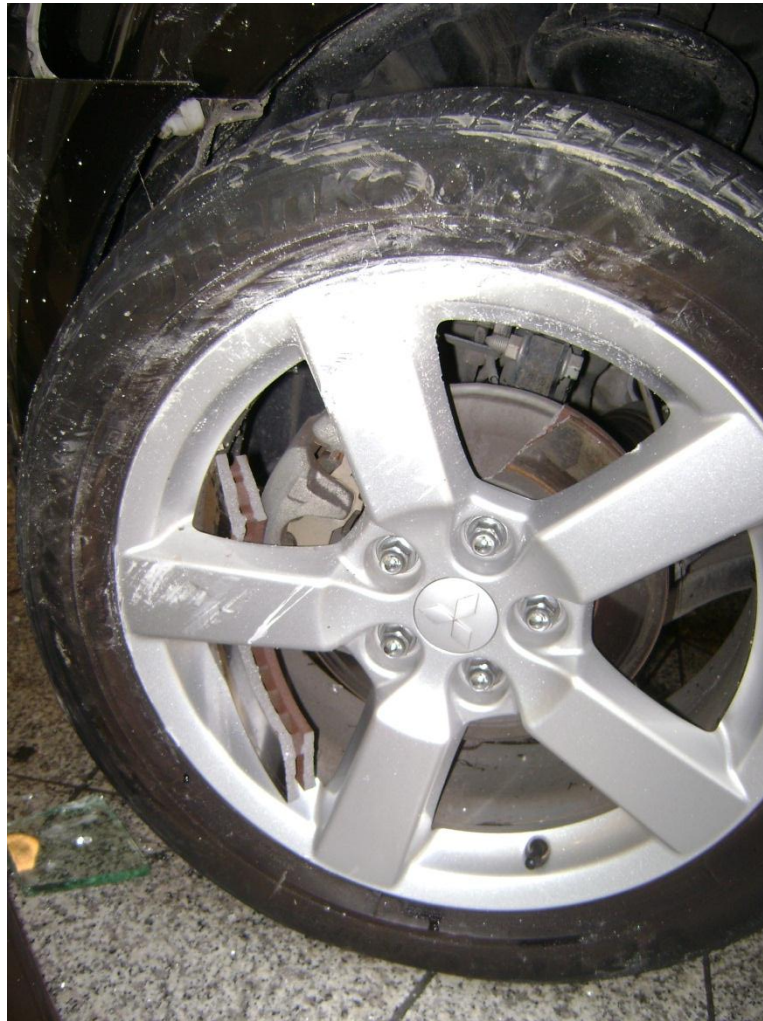
**From Fig 10: Broken off segment of LH front Disc Brake Rotor**

The broken off sector appears to have been balanced on the lower wheel rim between two spokes, presumably to enable the photograph to be taken. Were the broken segment to be presented to a metallurgist for examination, I am sure that they would be able to provide some useful information about where the cracks initiated and how they propagated.

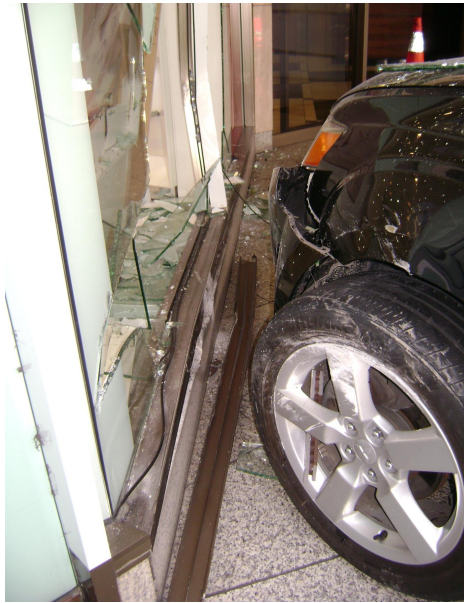
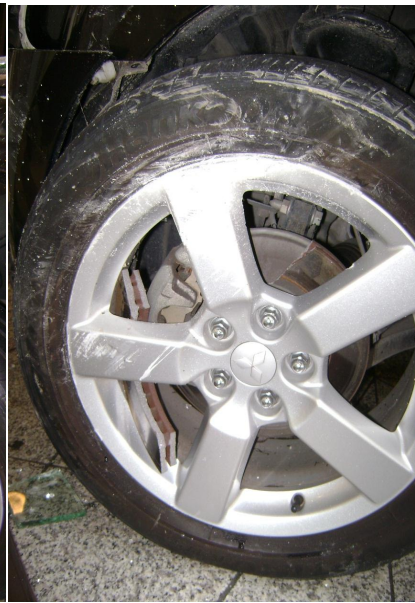
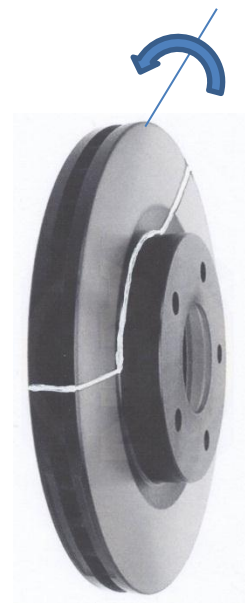
It is clear that during the sudden acceleration incident the vehicle became caught between the angled shop window on the left hand side and the pillar on the right hand side. The left side of the vehicle hit the angled glass window and its support structure and the right hand wheel appears to have been spinning against the pillar to its right.

Figs 10 and 11 repeated above are police photographs of the LH front wheel after the sudden acceleration incident. There are signs of scuffing of the surface of two of the alloy spokes at the 9 o'clock and 11 o'clock positions. However the spokes at the 2 o'clock, 5 o'clock and 7 o'clock positions show absolutely no signs of surface damage whatsoever. The tyre is intact and inflated and shows some signs of wall scuffing between the 9 o'clock and the 1 o'clock positions and some signs of a white deposit on the road surface of the tyre at the top of the wheel. The tyre wall at the bottom of the wheel appears clean. This suggests local impact on one sector of the wheel only.
