1 Typical conventional Bowden throttle cable 1999 RHD Toyota Corolla

1 Electronic Throttles

3 The CTS Accelerator Pedal

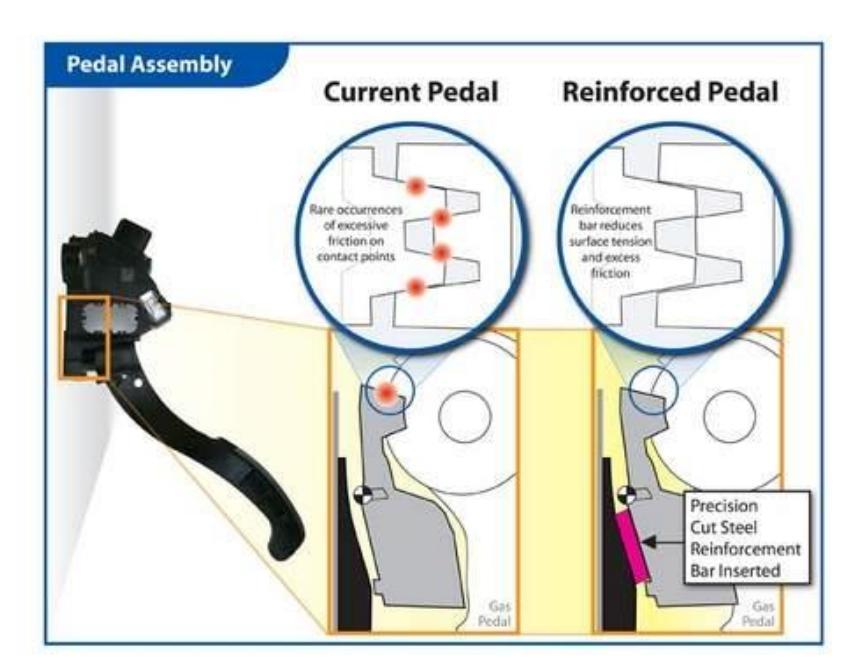
Fig 4: Diagram of Toyota pedal construction emanating from Toyota

It looks as if something approximating to the 2008 patent has been used in practice rather than the 2004 patent. What Toyota propose inserting in their recall "fix" is what they call a "Precision cut steel reinforcement bar", as shown. Its function would appear to be to prevent the grey lever from rotating too far clockwise about its pivot and applying too much braking force and hence jamming. See Fig 4

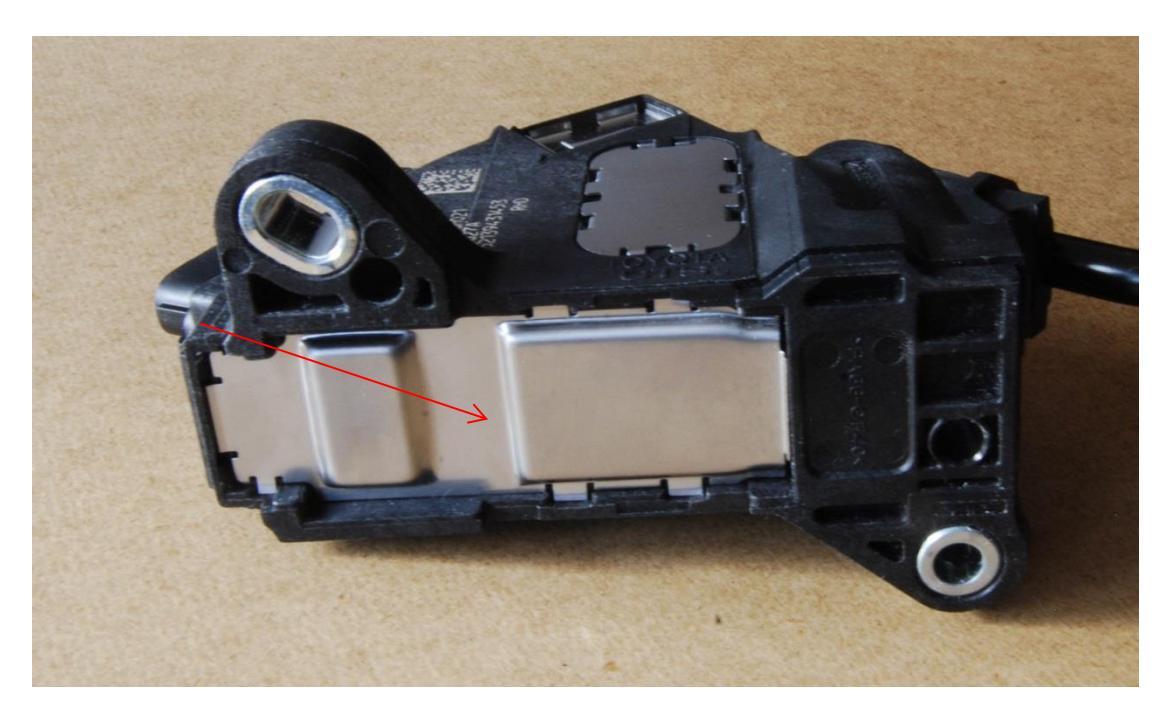
Fig 6 Underside of CTS Pedal (2010 Yaris). Magnetic stainless steel closing in plates clip into place and are not sealed against the plastic accelerator pedal body.

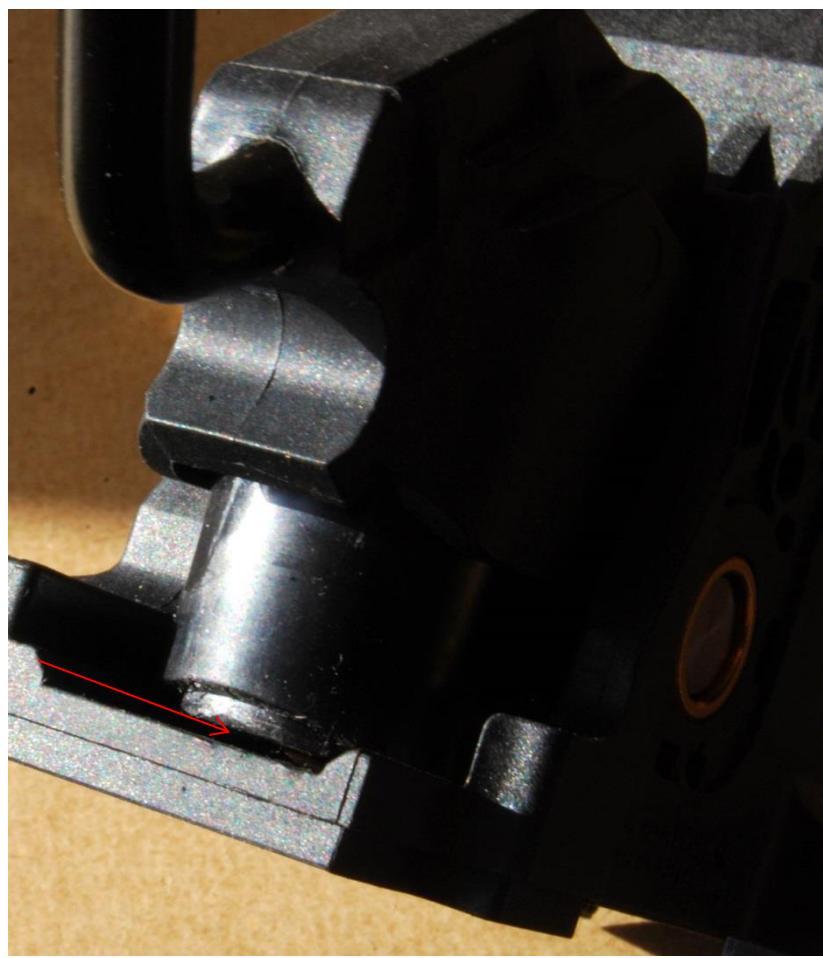
Fig 7a : Rear view of Pedal showing gap where rectangular spacer is supposedly fitted under the recall program

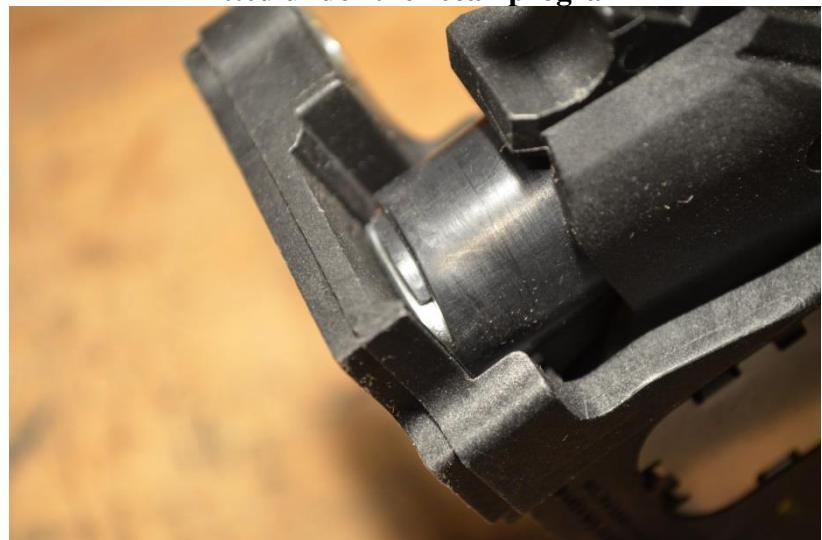
Fig 7b: metal shim in place Toyota Auris

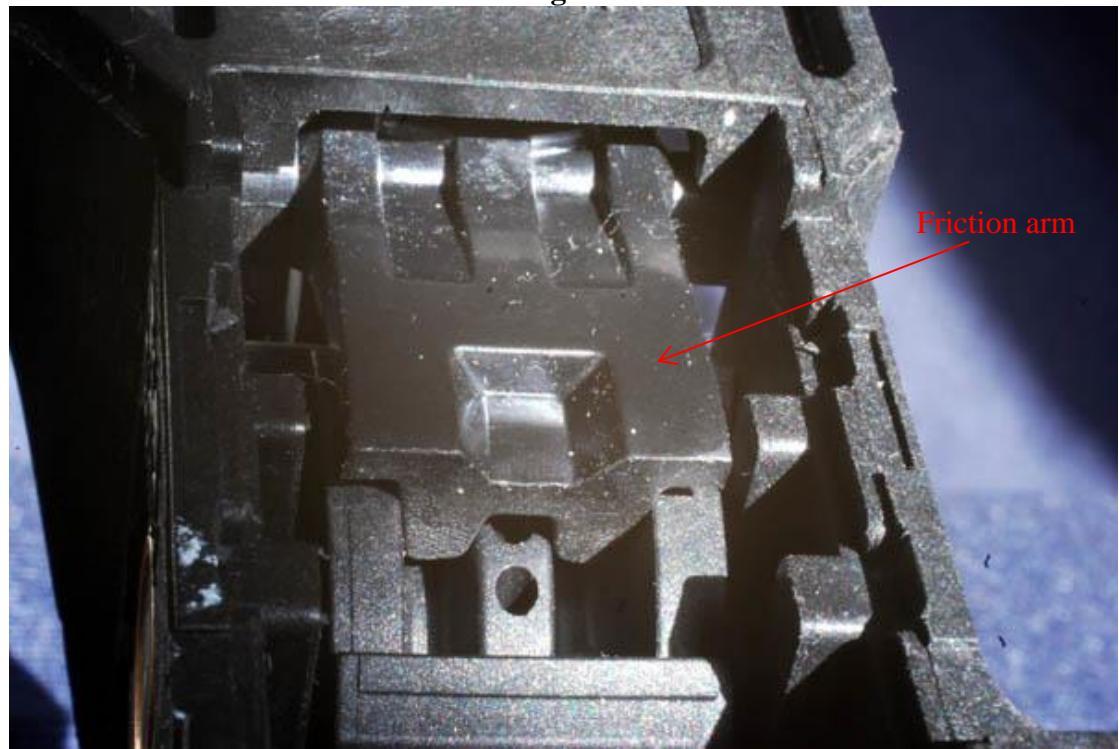
Fig 9 : Double V notched friction lever arm and matching double V notched rotating drum. (Original design) The other end of the lever arm retains the pedal spring so that when pedal force is applied by the driver to the pedal the male projections on the friction arm are pressed into the matching female notches on the drum to provide mechanical hysteresis.

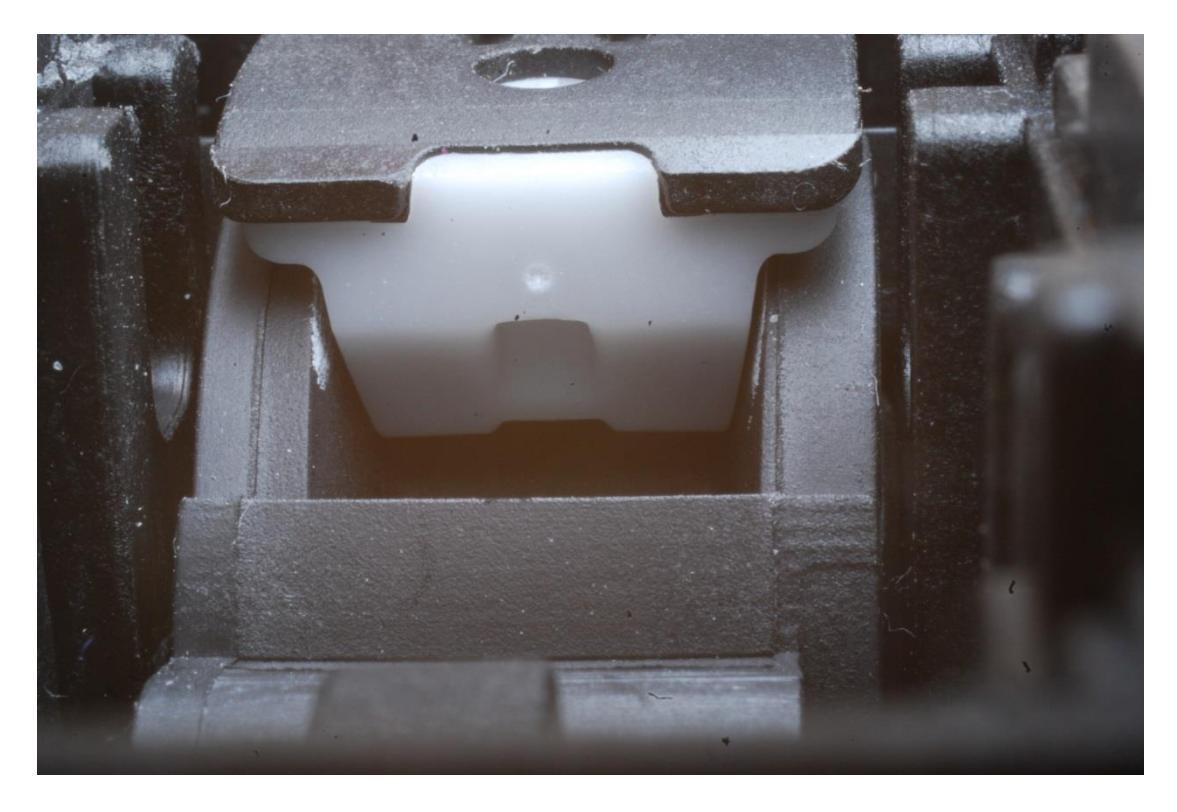
Fig 10 – Revised Single V friction pad arrangement

This design was sold to me under the same part number as the original and I was told that it had the spacer plate fitted. As can be seen it is a redesign with a different plastic used for the friction pad. There is now a single double width male V projection fitting into a single broad female V notch. In effect the contact area for the friction pad has been halved.

As far as I am aware, this re-design has never been declared.

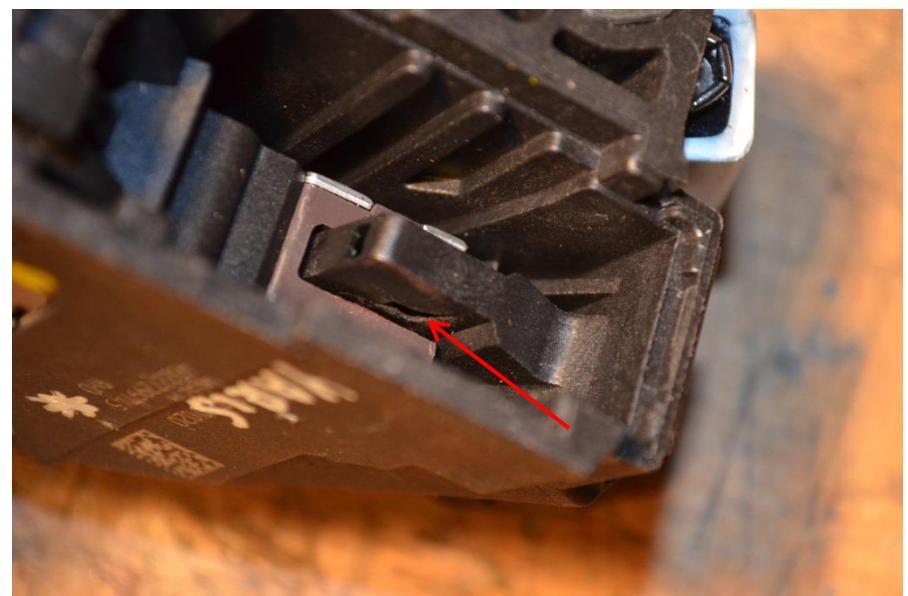
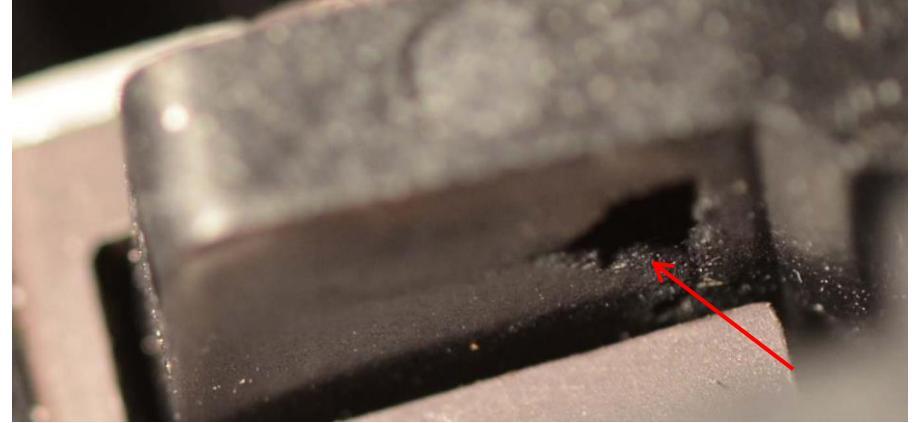
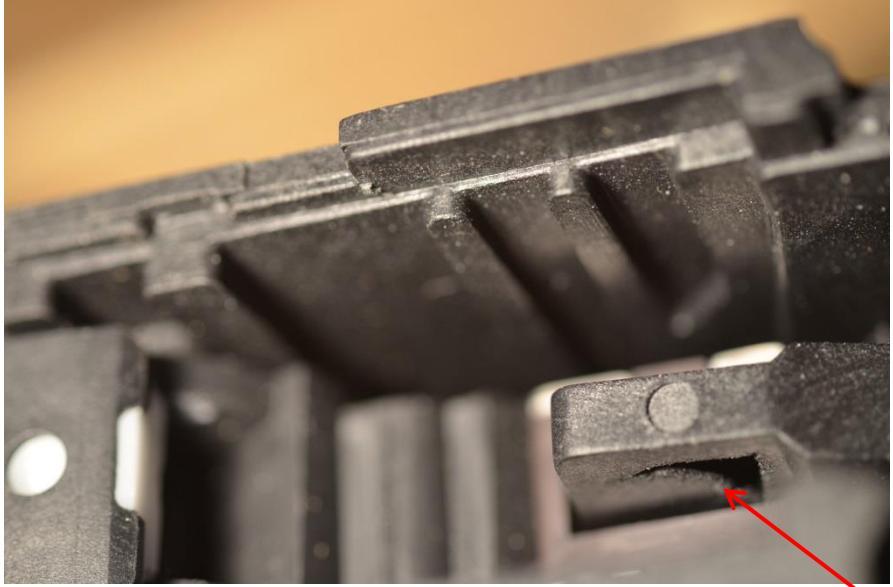
Fig 11: Damage to wall of protective pocket for Accelerator pedal sensors

Fig 11 shows a flaw that appears to be present in the wall of a number of CTS pedal assemblies in the protective pocket that surrounds the Hall Effect electronic sensors that measure pedal position.

I presume that this is a manufacturing flaw caused by imperfect casting.

The flaw, as show in Fig 11 would also allow the ingress of moisture.

This of itself might not matter were it not for the presence of the flaw shown in Fig 11. Eventually wear might allow one of the magnets to catch and occasionally prevent the return of the pedal to the idle position.

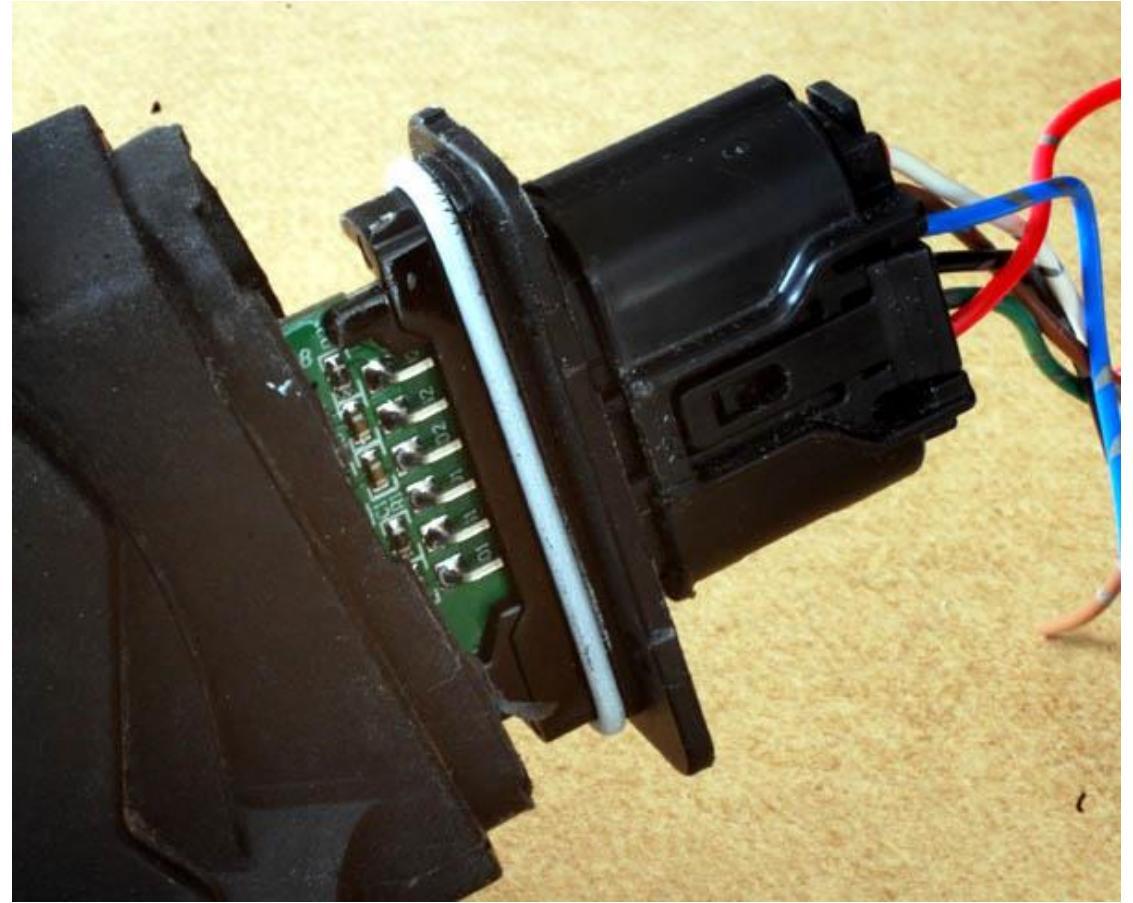
Fig 13 : Sensor PCB partly removed from sheath within pedal assembly. Although there is a flexible seal to prevent water ingress, the sheath has a rectangular hole which would allow moisture in from the magnet space.

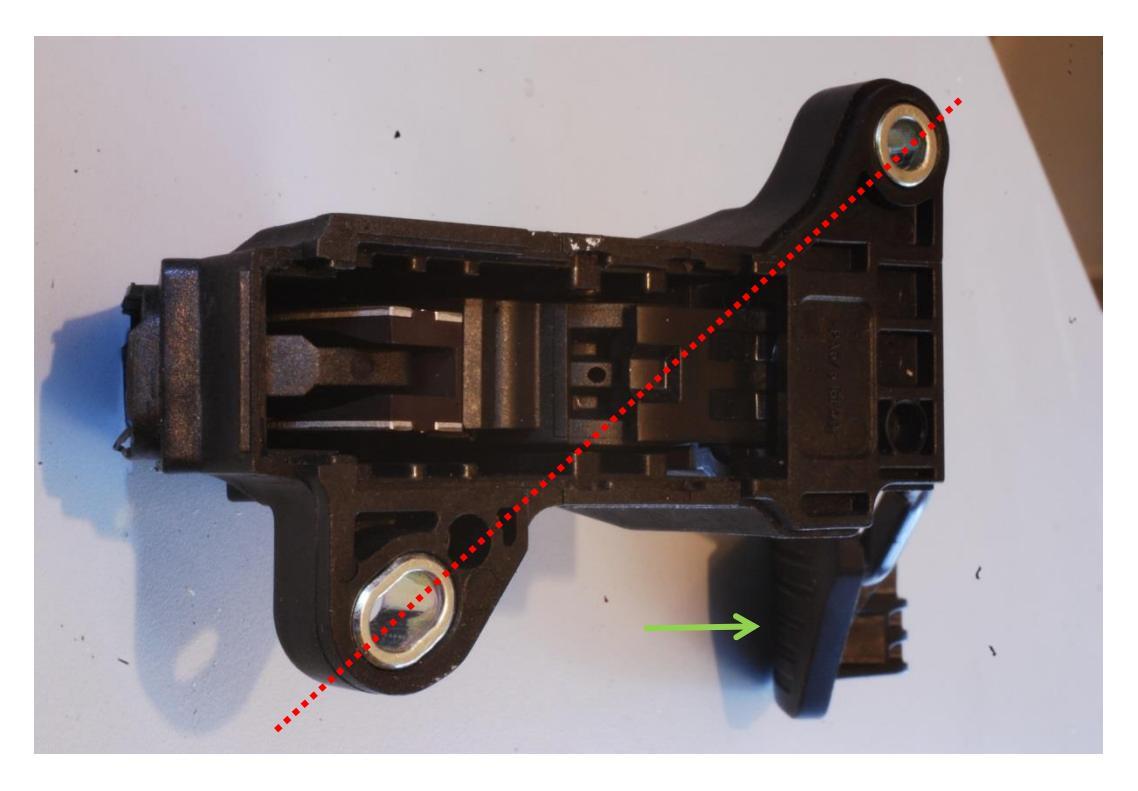
Fig 13 Underside of the pedal assembly box, showing the diagonal fixing arrangement

The moment that the driver presses on the pedal, a turning moment is exerted about the holding down axis that distorts the pedal box structure with the effect of pushing one magnet towards the pocket containing the electronics. In some cases this will result in the magnet rubbing against the pocket.

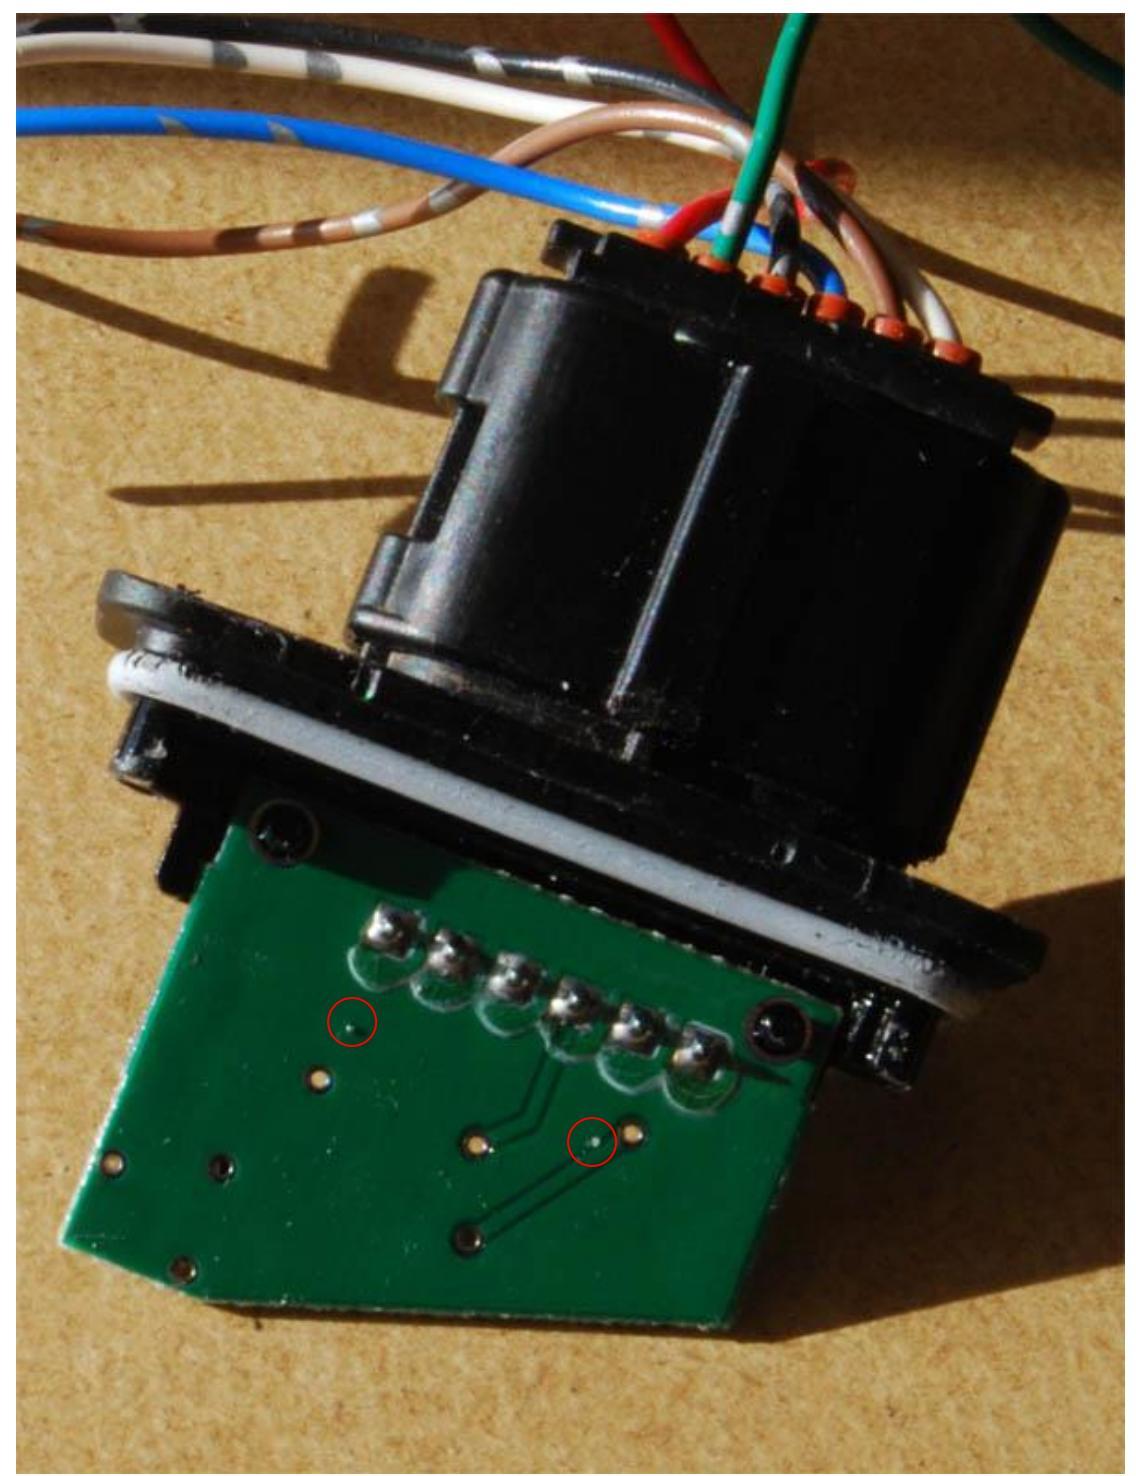
Fig 14 : Non-component side of PCB. Solder globule and solder splat (circled in red) are trapped under varnish. Note the cracks in the protective coating near where connector pins are soldered to the PCB. Is this indicative of poor quality control? (2009 MY scrap Yaris exemplar)

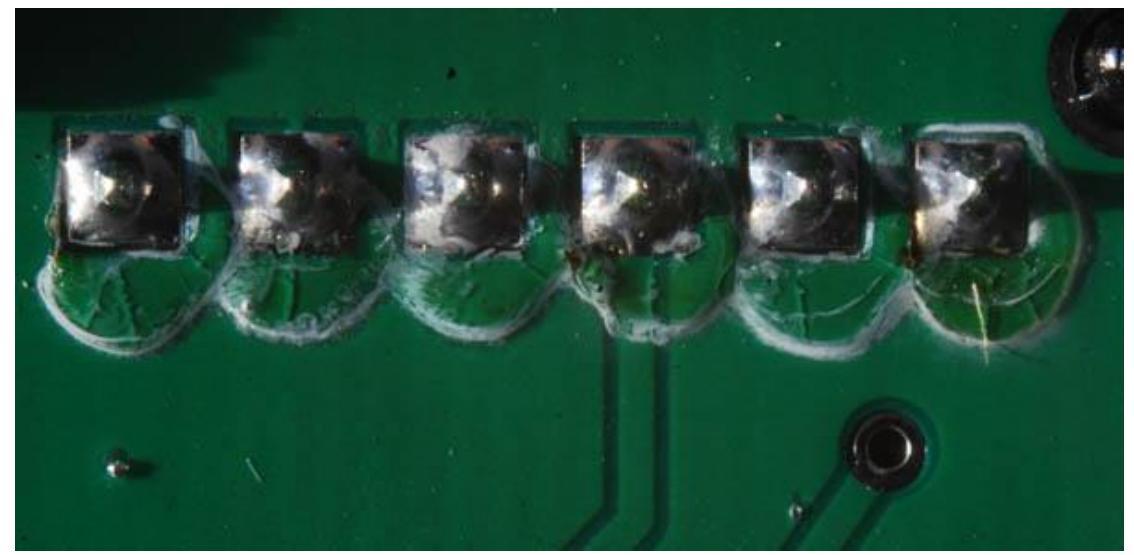
Fig 15: Close up of cracks in coating on all six connector pins. Solder globule and solder splat can also be seen (2009 MY scrap Yaris exemplar)

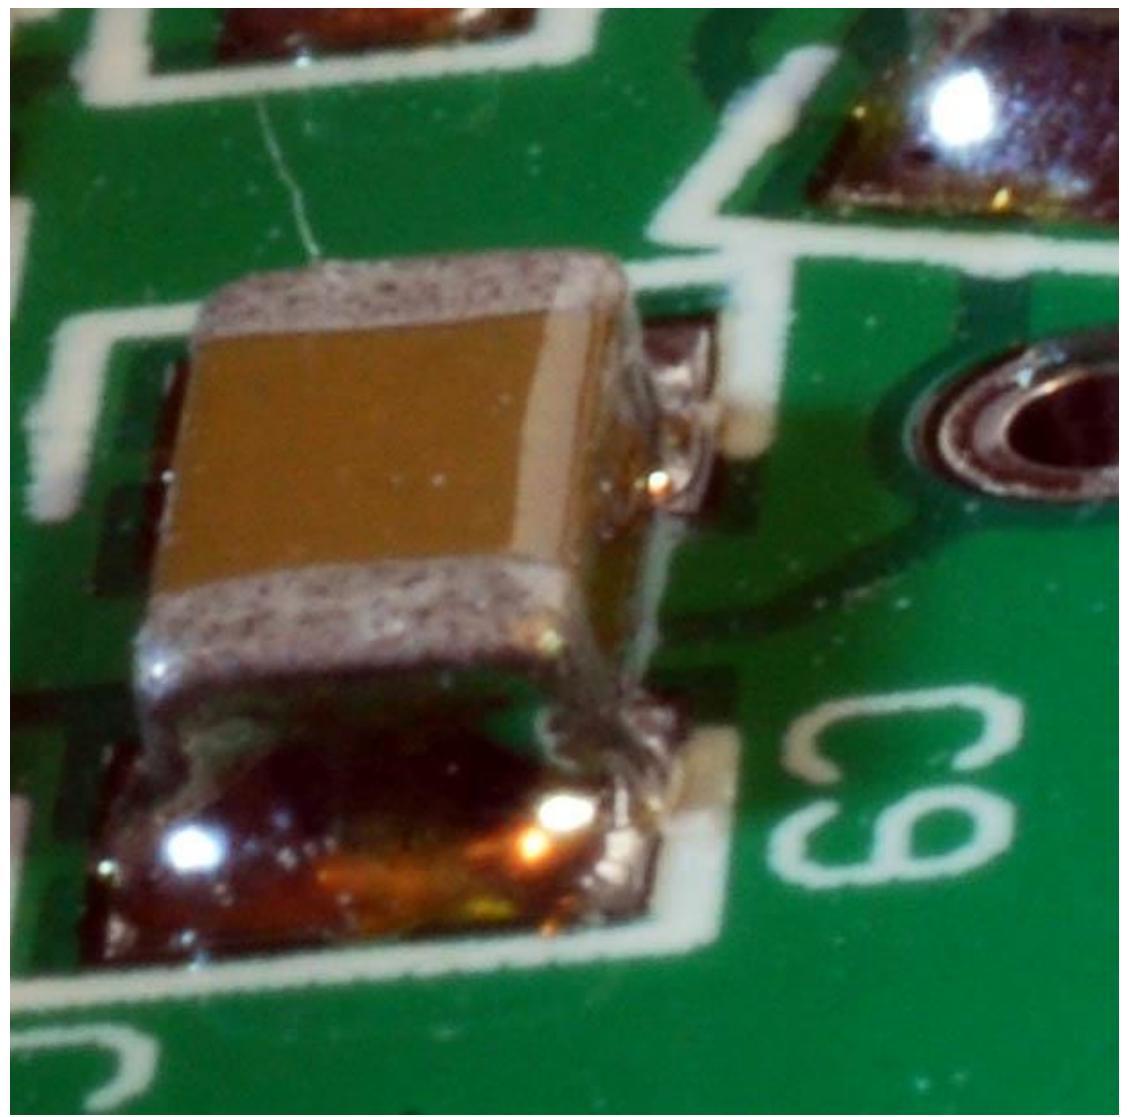
Fig 16 Possible tin whisker on C9

Note: No certainty here!

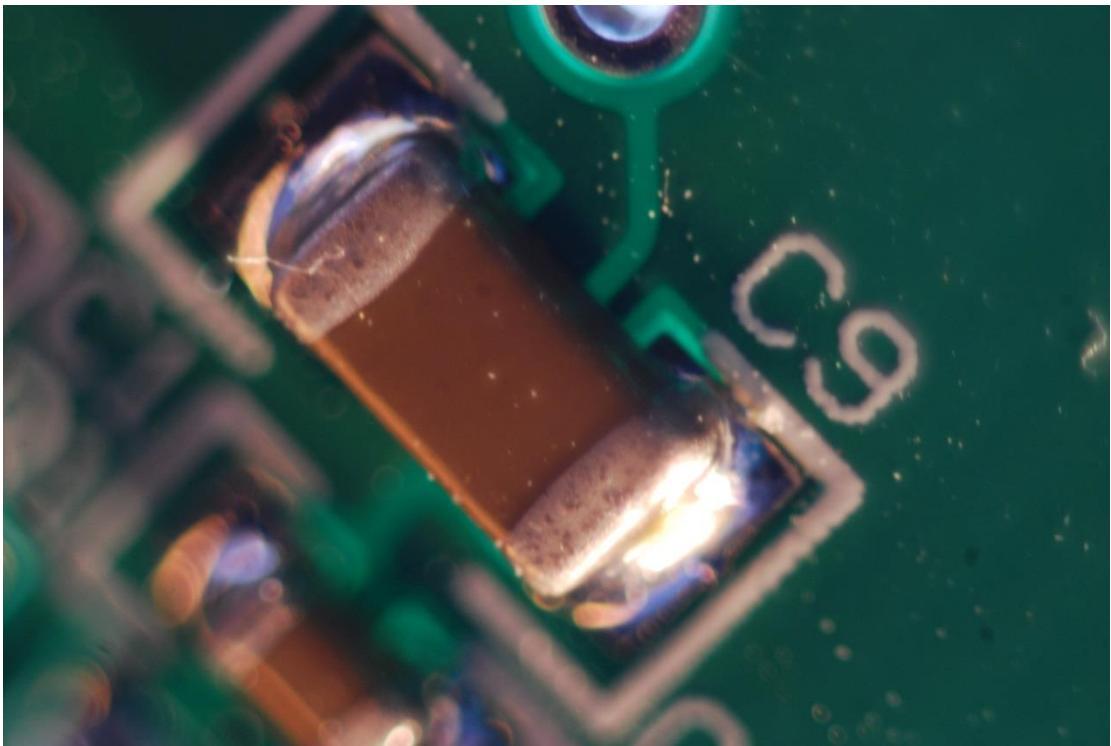
Fig 17 Possible tin whisker on C9

Note: No certainty here!
