1 Typical conventional Bowden throttle cable 1999 RHD Toyota Corolla

1 Electronic Throttles

3 The CTS Accelerator Pedal

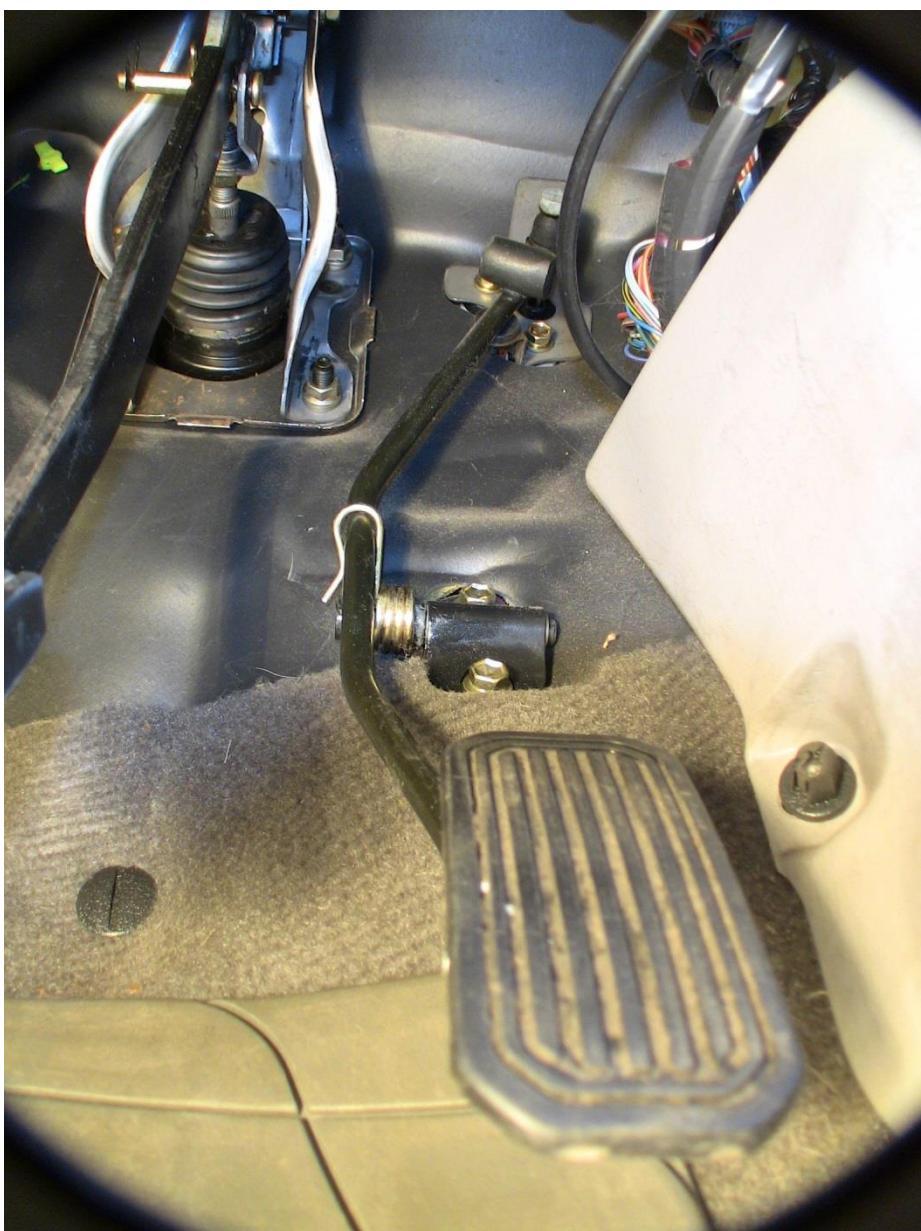
Fig 1. Accelerator pedal on a 1999 RHD (UK) Toyota Corolla

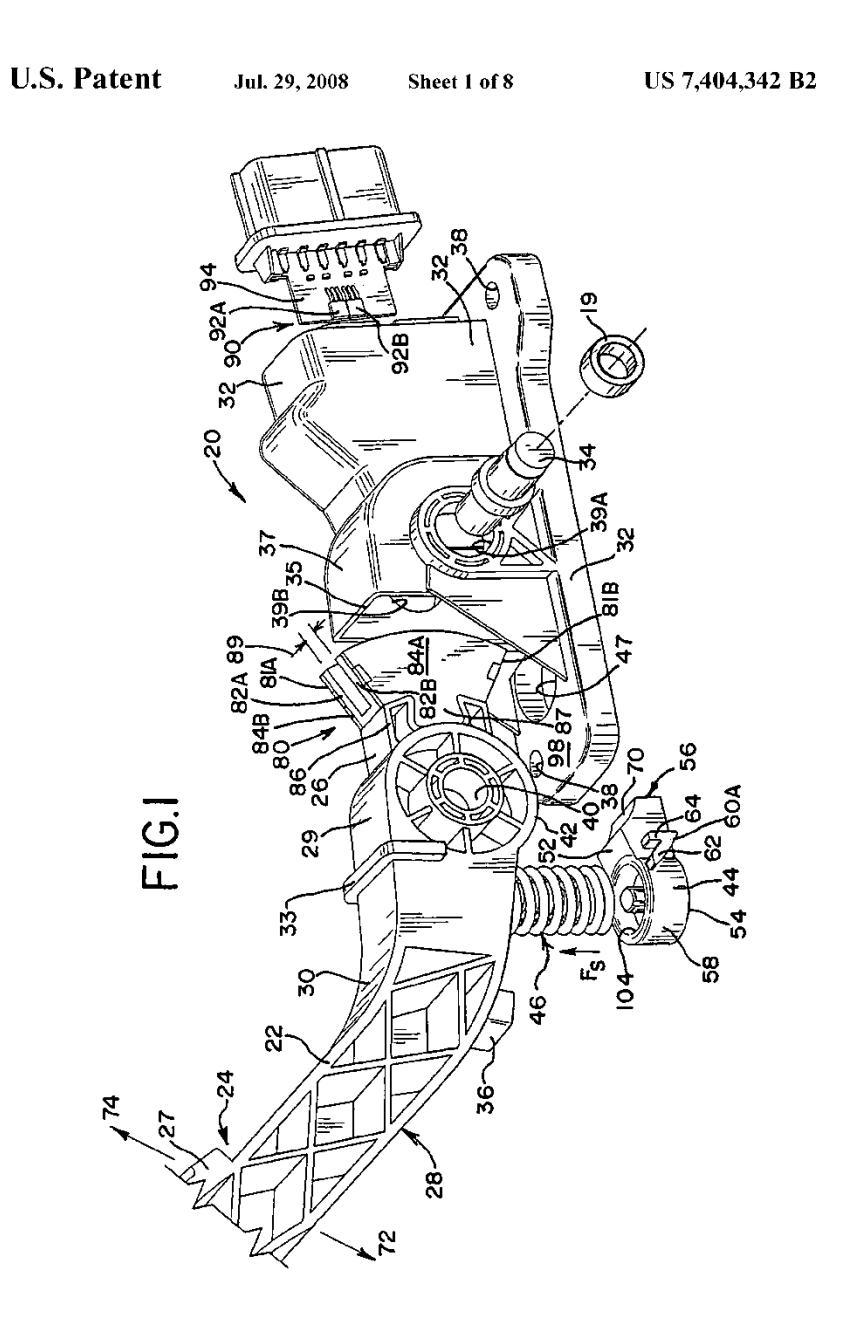
Fig 2 example of disassembled pedal from patent specification (CTS patent).

In the above disassembled view, when the pedal is depressed this compresses spring 46 which in turn applies a force to the circular spring holder which pivots and forces circular surface 70 against the drum. See the patent for details.

Now this may not be the exact arrangement and CTS have a patent for a completely different arrangement. Note that this shows two Hall effect sensors side by side at 92A and 92B. In the actual design the two sensors are in the same IC package

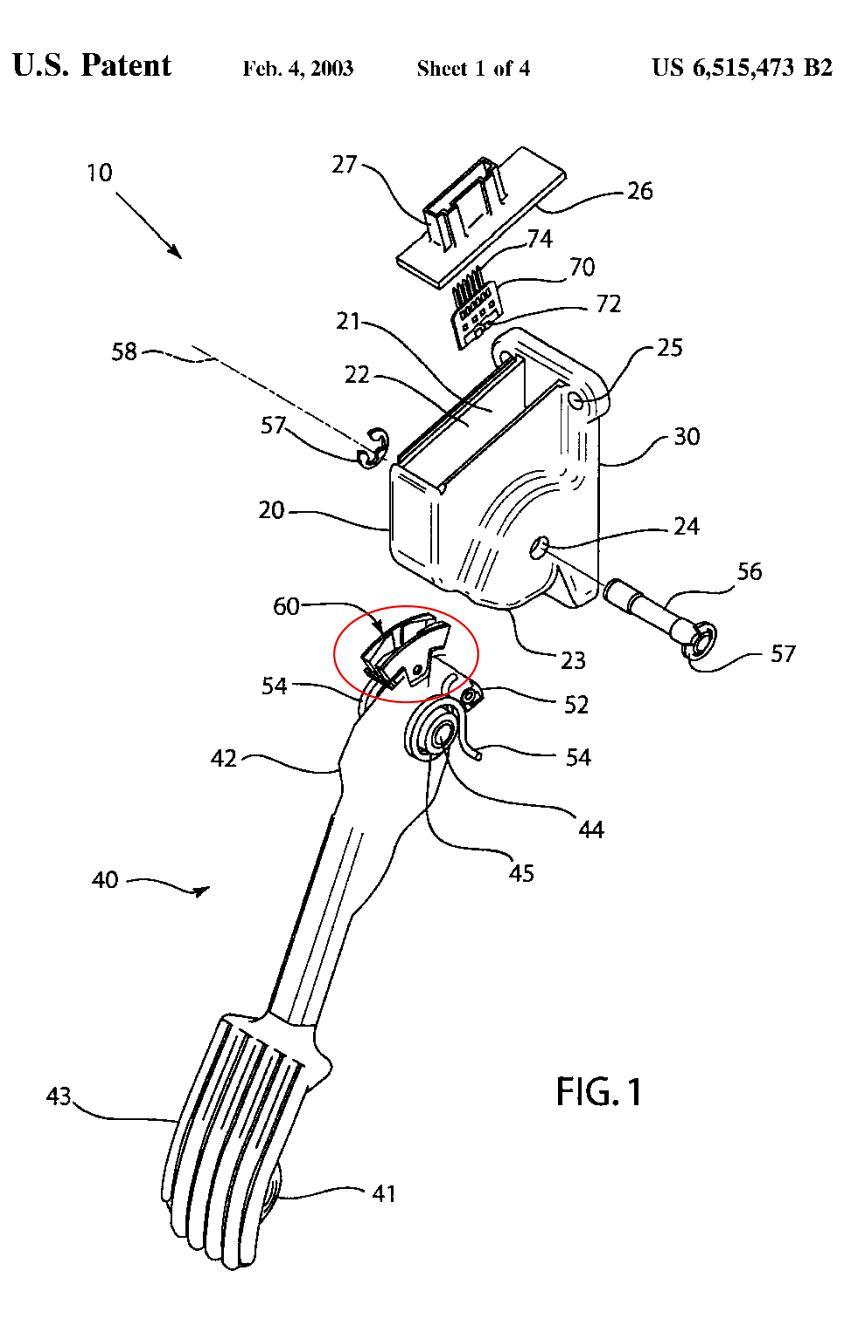
Fig 3 – Alternative CTS pedal

The friction plates are not shown in the patent (USP 6,809,512 Oct 26 2004 and two others). Double tapered magnet assembly ringed in red. (North – South -North – South)

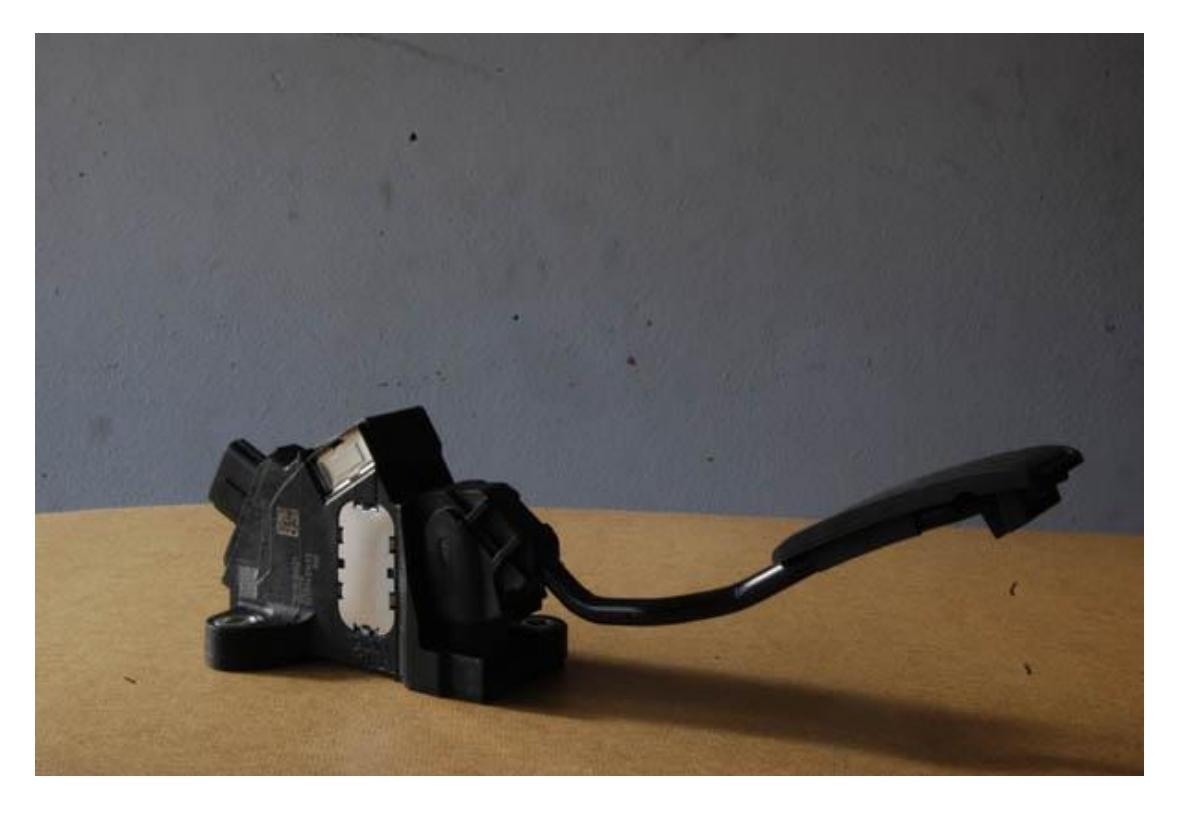
Fig 5 Typical CTS Pedal 2010 Yaris (UK Spare 2010)

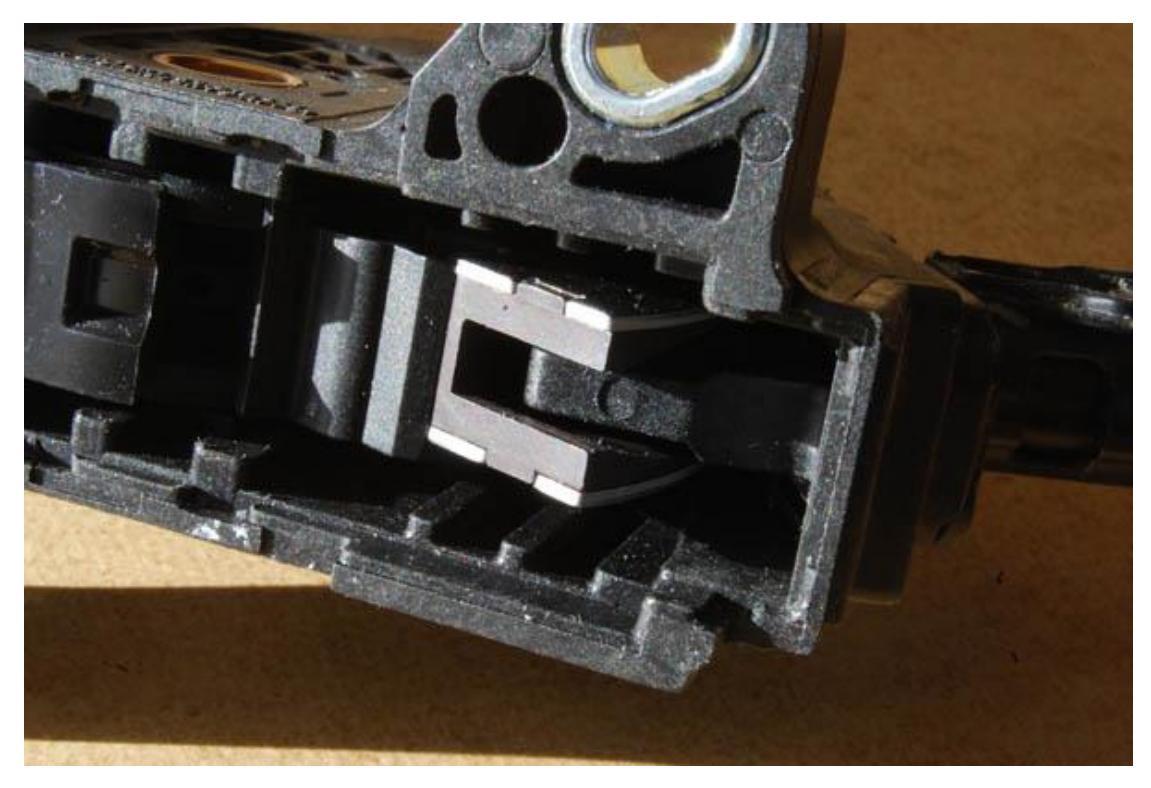
Fig 8 : Close up of two halves of moving tapered magnet assembly with stationary housing for pedal angle sensor PCB between the two halves of the magnet.

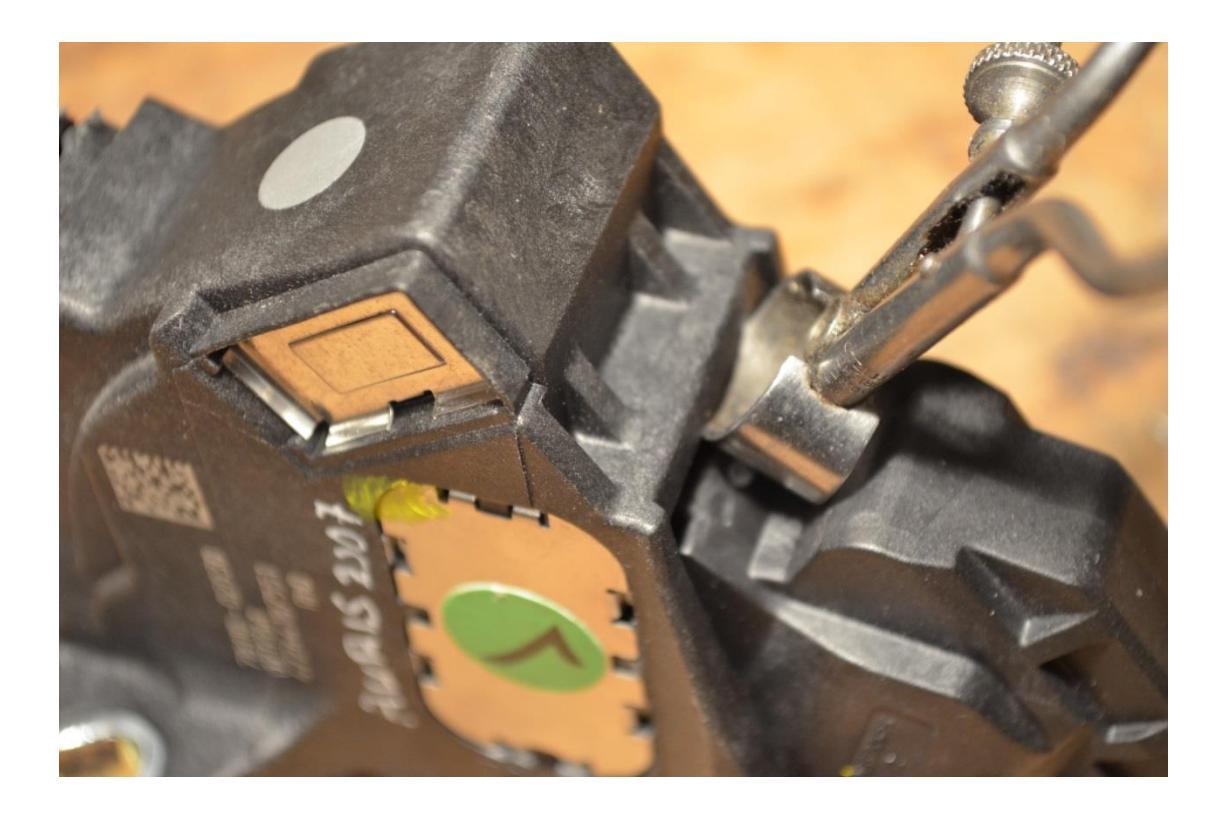
This flaw is normally hidden by the magnets. The only way that I was able to get the pedal to stay depressed to allow photographs was place the tapered caliper head in the gap as shown in Fig 12..

12 Calliper head used to keep throttle open. A wooden trapezoidal wedge would do the same

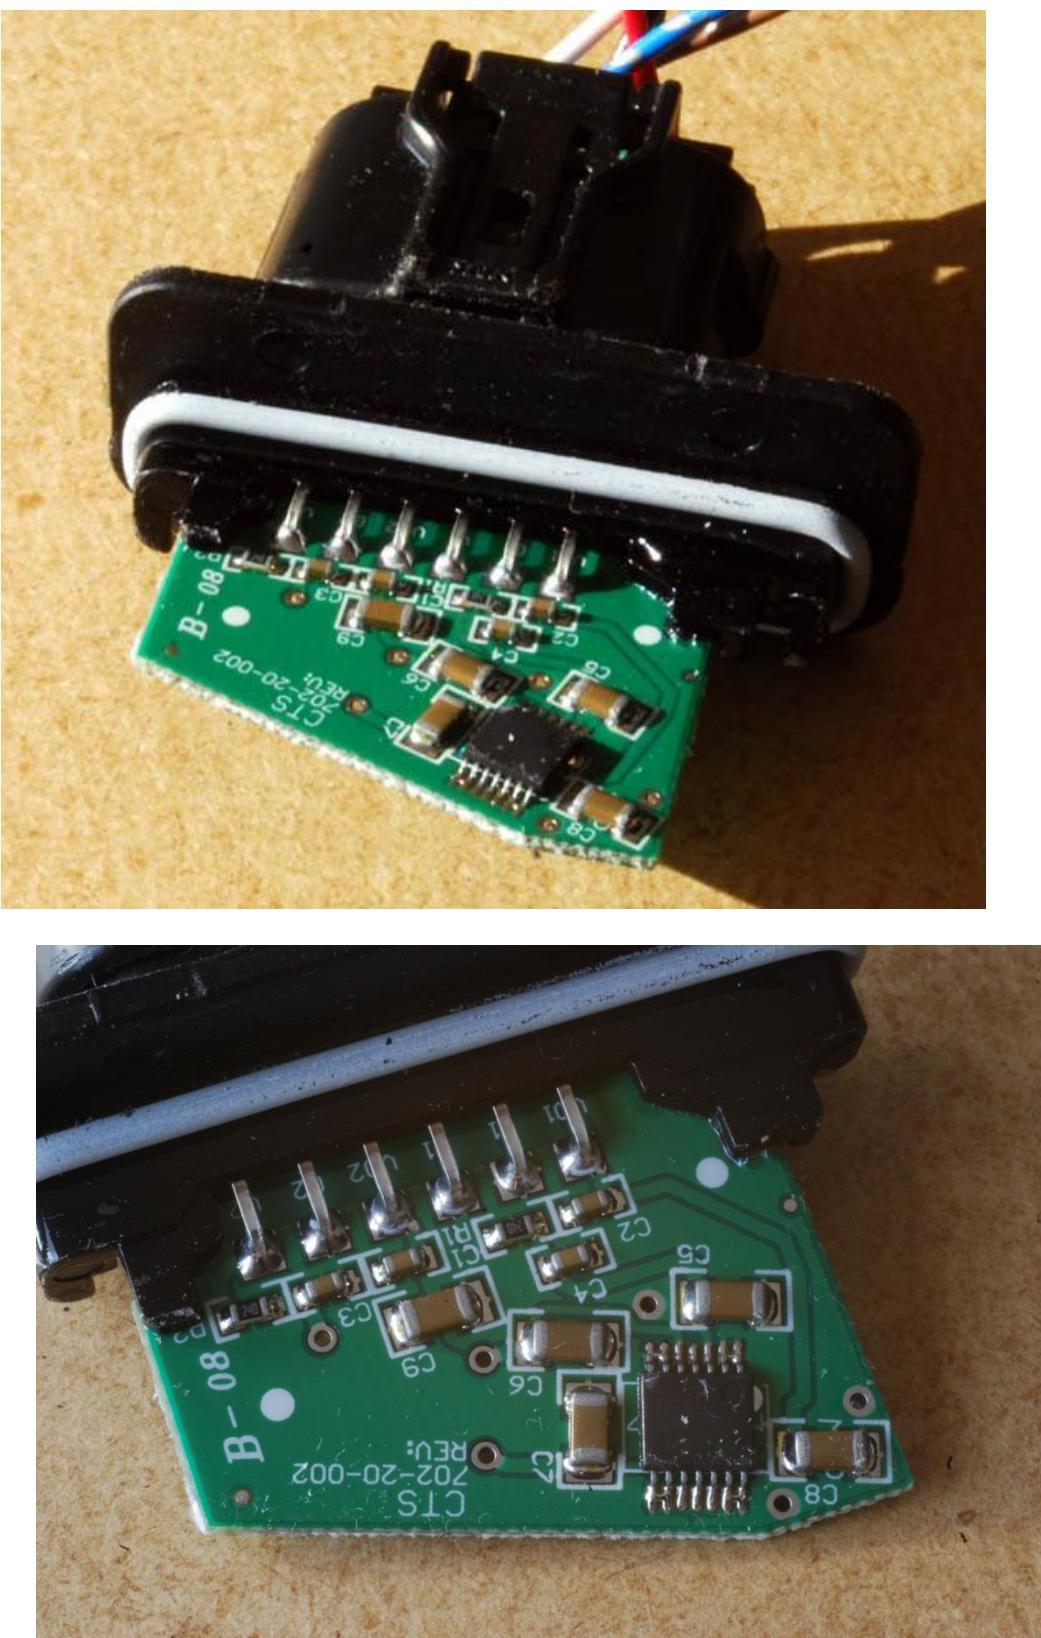
fig 12 : Photos of typical Sensor PCB and 6 pin connectors

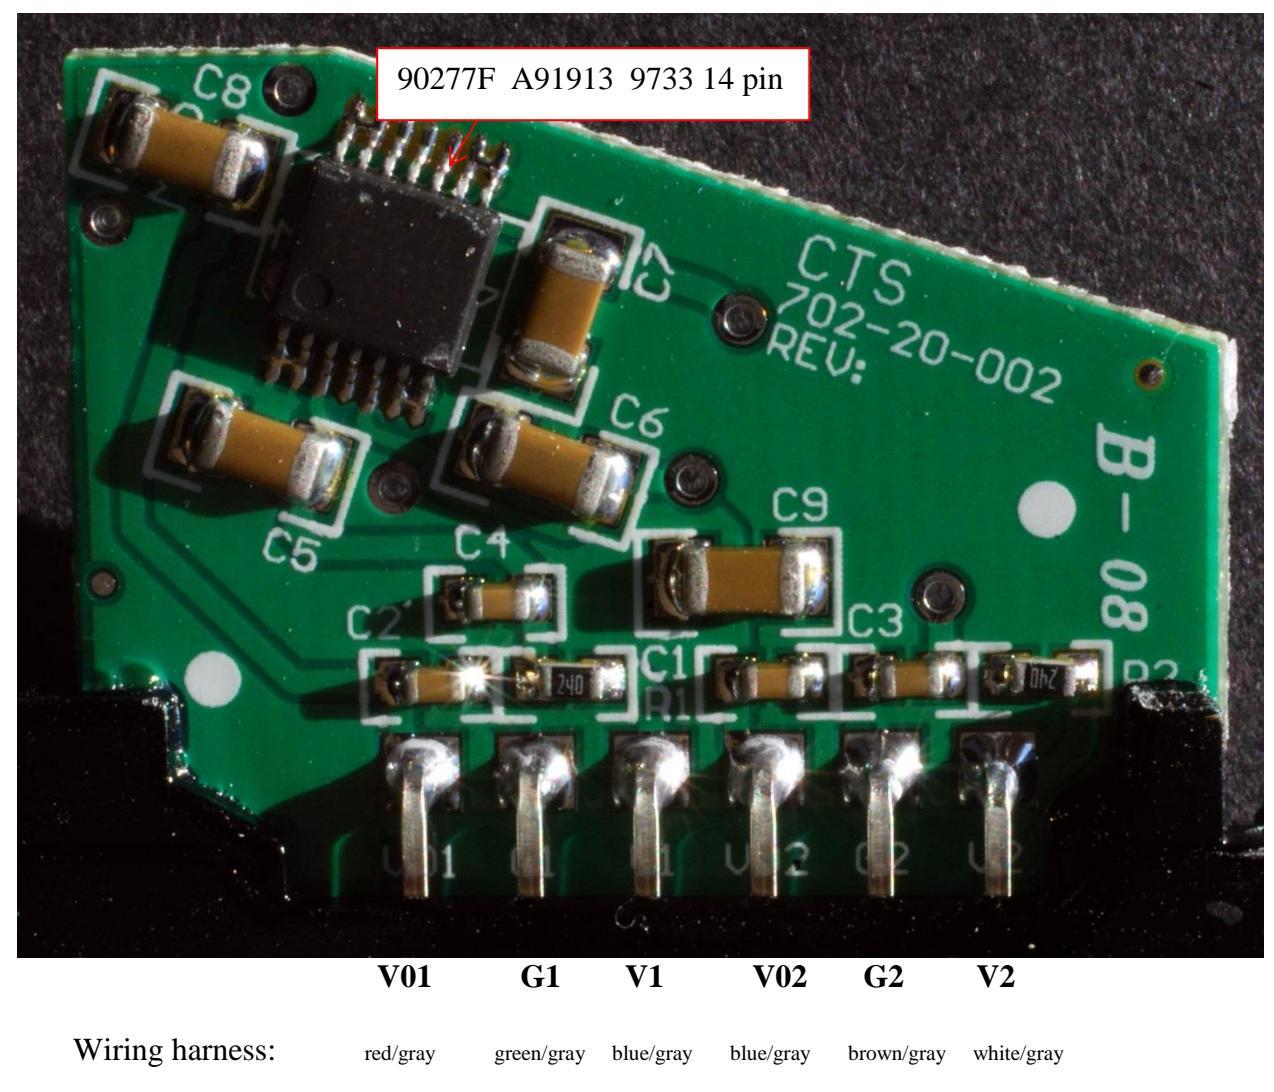
Fig 13 PCB showing pin connections

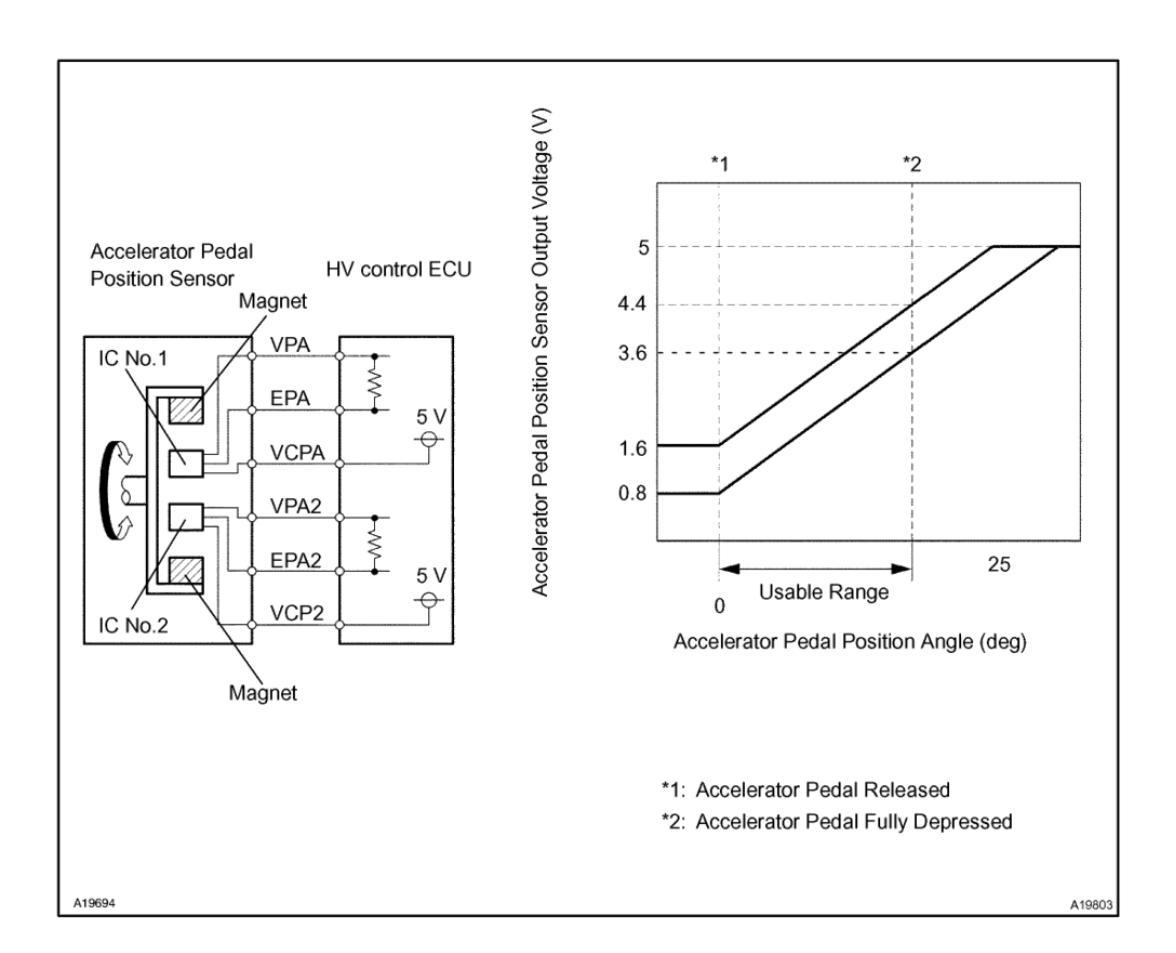
Fig 18 Typical diagram for Toyota Accelerator Pedal Sensor arrangement (In this case a Prius)

Fig 18 above shows that two magnetic sensors give voltage against angular position of the same slope. As I understand it, the difference in voltage between the two signals is monitored and if that difference should change then the ECU will shut down the vehicle to limp home mode, or so the theory goes.

One failure mode that does not seem to have been considered is what happens if the magnetic field in the airgap either increases or decreases. A decrease in the airgap flux density will result in the pedal angle sensor voltages decreasing. This is equivalent to reqesting a decrease in throttle angle. An increase in the airgap flux density will result in an increase in the sensor voltages – equivalent to a request to increase the throttle angle.
