**REPORT OF DR A F ANDERSON  
INDEPENDENT ELECTRICAL ENGINEERING CONSULTANT  
DATED 9th May 2012**

**Specialist Field : Electrical Engineering**

**Subject Matter : Sudden Acceleration/Surge Incident Brandon Street,  
Wellington NZ Friday 20<sup>th</sup> January 2012**

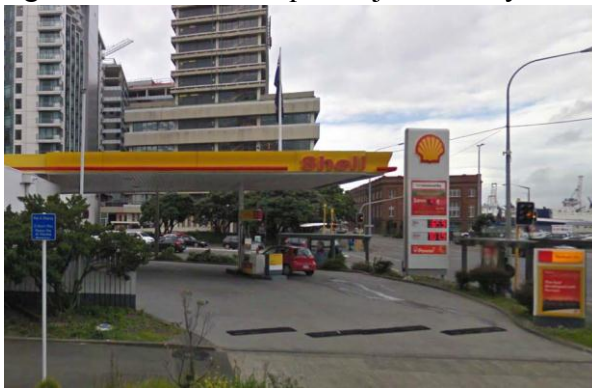
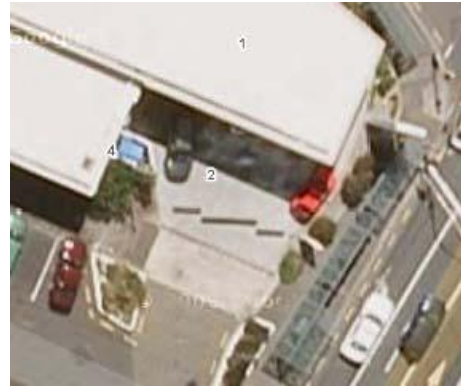
**Fig 2 Small speed humps at entrance to garage**

Fig 2 above shows the small speed humps inside the garage forecourt.

<sup>14</sup> Sometimes the shock from going over a bump or a wheel falling into a pothole can seriously disturb electrical contacts in the connectors between electronic systems and the wiring harness and battery connections. Sudden accelerations have been known to be triggered by such disturbances. For example NHTSA ODI Complaints 10316132, 10314982 for Toyota Prius vehicles.. In this instance there is no indication of any kind of change in vehicle behaviour after upon going over the bump.

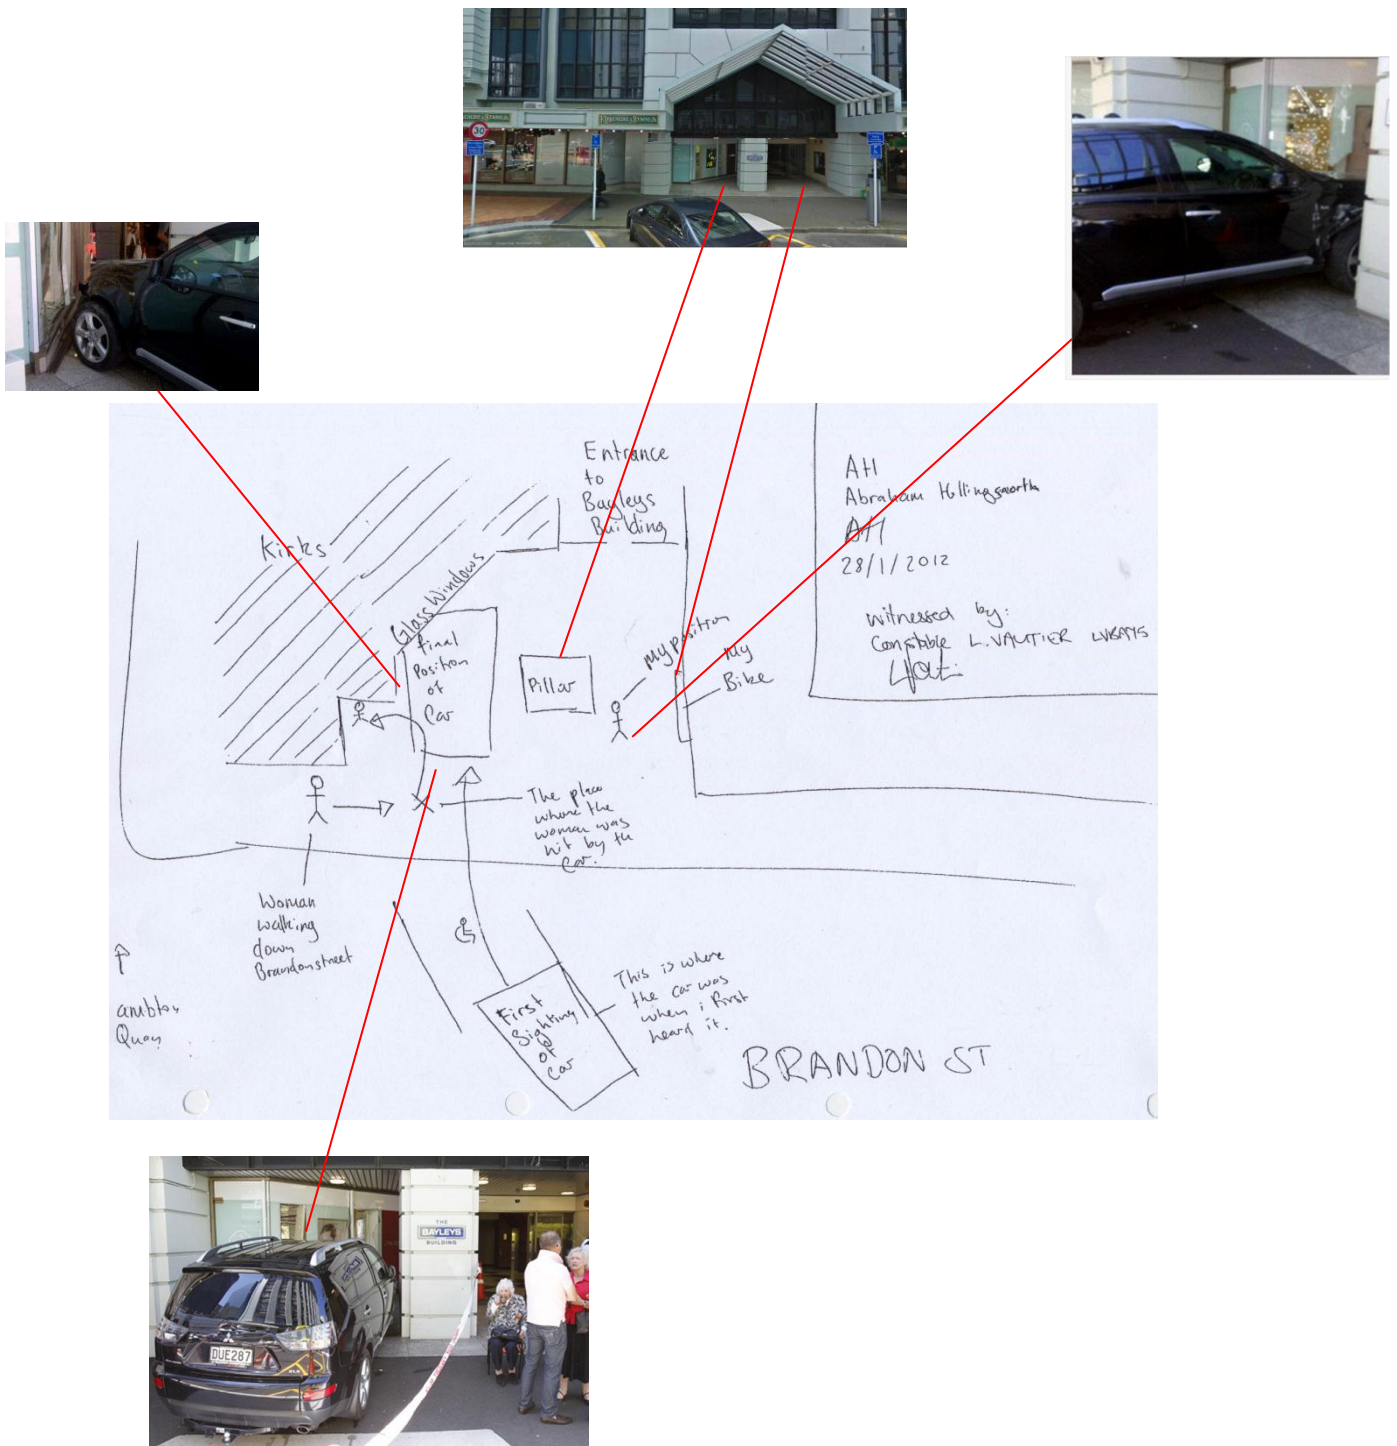
**Fig 17 HOLLINGSWORTH'S sketch with some of the press photographs from Fig 8 to provide orientation of the crash scene**

The witness Abraham HOLLINGSWORTH was standing next to his bicycle, having just made a delivery to the Bayley's Building adjacent to Kircaldie & Stains. Fig 9 shows his sketch of the accident scene to which I have added various press photographs from Fig 8 to provide orientation. He was only a few metres from the driver's side of the vehicle at the time of impact, as shown in the sketch.

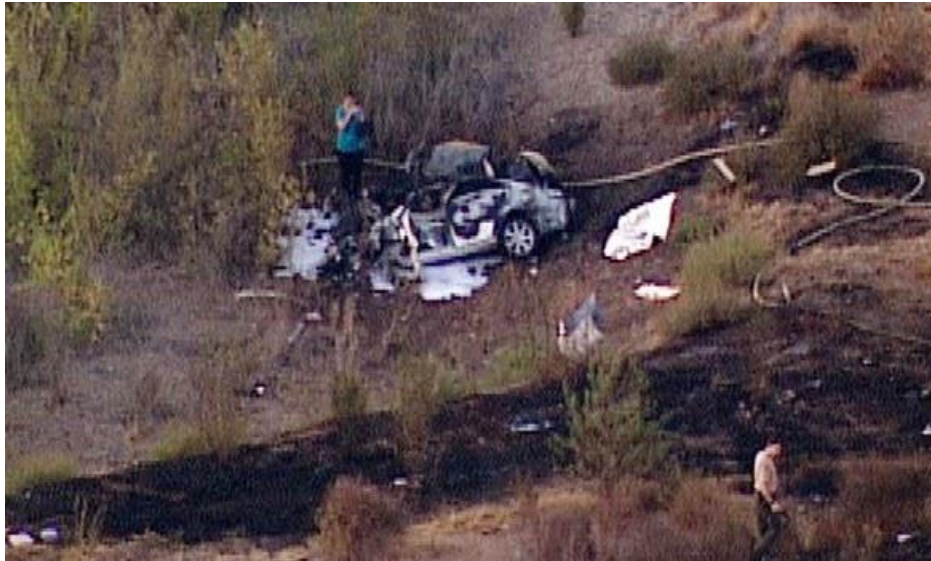
**Fig 20 The Saylor crash August 2009 4 people killed**

Following the introduction of electronic throttles there was a rise in sudden acceleration incidents that was by no means confined to one manufacturer. Sudden accelerations would undoubtedly have been prevented had independent fail safes been provided. The result of not providing an independent fail safe was made abundantly clear by the horrific Saylor crash in California in late August 2009 when four people were killed in a runaway Lexus<sup>33</sup>. See Fig 20.

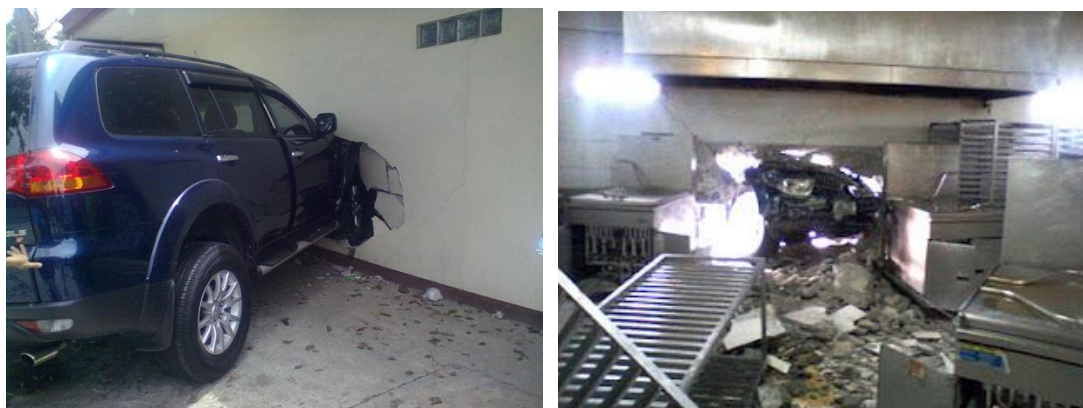
**Fig 22 Montero hits wall after SA event – Philippines**

I searched the NHTSA complaints database for Mitsubishi vehicles for the years 2007 to 2012. I could find no complaints for Outlanders. However Mitsubishi report 10 complaints worldwide.<sup>47</sup> In the NHTSA database I could only find one instance of a sudden acceleration from standstill and this was in a Montero Sport that turned out to have occurred in the Philippines. Further search on the internet revealed a spate of sudden acceleration incidents in 2009-2011 Montero Sports vehicles in the Philippines reported on a blog spot<sup>48</sup>, a selection of which I include in Table 1. I have only included examples where the vehicle had accelerated from braking. Fig 22 shows a typical example.

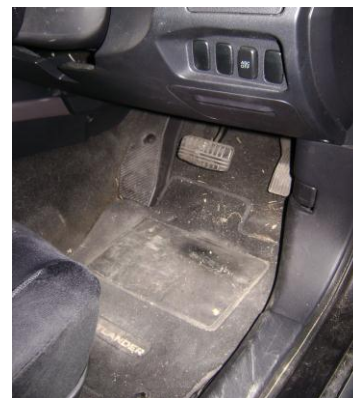
**Table 3 Brake and accelerator pedal and shoe measurements**

Width of brake pedal	11 cms
Width of accelerator pedal	3.5 cms
Horizontal distance between the two pedals	9 cms
Relative height of brake pedal above accelerator pedal	3.7cms
Width of DEFENDANT'S shoe	8 cms tapering to 2cms at toe
Length of DEFENDANT'S shoe	25.5 cms

The horizontal distance between the brake and accelerator pedals is 9 cms<sup>58</sup> and the width of the DEFENDANT'S shoe is 8 cms. If the heel of the shoe were placed in a pivotal position to enable the driver to press either the brake or the accelerator pedal comfortably – i.e. approximately midway between the brake and accelerator pedals - the shoe would pass between pedals with a total clearance of 1cm<sup>59</sup>. In practice a driver would have their foot on the brake pedal when braking, and the clearance between the right side of the right foot and the left side of the accelerator pedal would be considerably greater than 1 cm. Therefore, in my opinion, it is reasonable to eliminate the hypothesis of pressing on both brake and accelerator pedals at the same time as a potential cause of the sudden acceleration.
