Effects of Conformal Coat on Tin Whisker Growth

Abstract

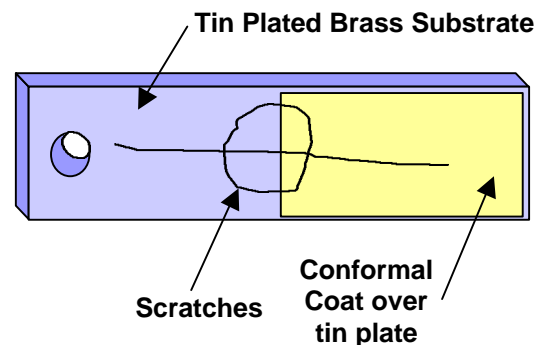
Figure 1. A specimen

The literature reports that the bright tin plating process is most susceptible to whisker formation and suggests that this is caused by residual stresses in the surface material [5], [6]. The thickness of the tin plating plays a significant role to whisker formation as well. Tin plating that is too thin (less than $0.5\ \mu\text{m}$) or too thick (more than $10\ \mu\text{m}$) does not promote whisker formation [8], [9]. For this experiment, several brass substrates (some with copper flash) have been plated using a "bright" tin finish. The brass substrates were coated with $5\ \mu\text{m}$ ($0.2\ \text{mil}$) of tin plating, which has been suggested to be the optimum thickness for whisker formation [8]. To further promote whisker formation, the plated samples were scratched using a knife blade, since scratches also create localized stresses that may promote whisker formation (Figure 1).

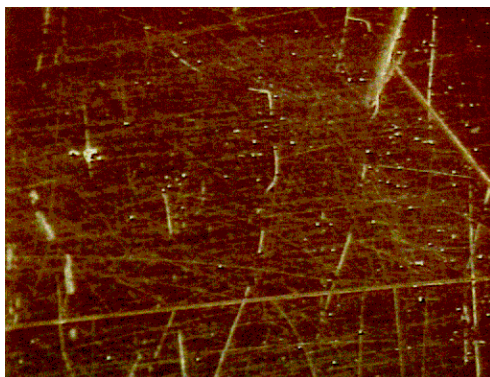
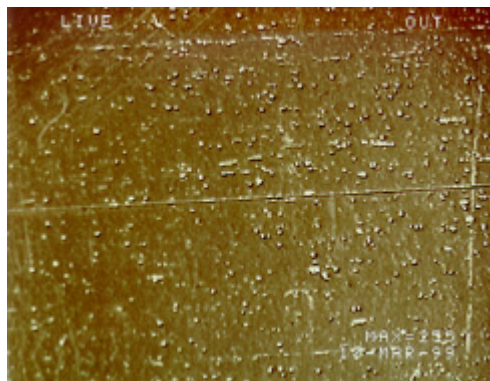
Figure 2. Density of Nodules

All samples are periodically examined using both an optical microscope and a Scanning Electron Microscope (SEM). The inspection was performed every two weeks for 3 months, and then once a month. Both tin nodules and tin whiskers were observed in less than a month following plating. Surprisingly, more nodules formed under the coating than on the non-conformally coated side. Figure 2 shows the nodule density on the coated side and the non-conformally coated side.

A. Non-conformally coated Side (x13)

B. Conformally Coated Side (x13)

our observations that more tin nodules formed under the conformal coat than on the exposed tin surface, we hypothesize that oxidation of the tin surface (exposed side) increases the incubation period for whisker formation.

Using a Scanning Electron Microscope (SEM), the whisker nodules were observed in more detail with high magnification. These nodule photos were taken of the non-conformally coated side. It was impossible to observe nodule formation on the metal surface on the coated side, since the coating is opaque to electrons. Furthermore, the insulating properties of the coating caused the specimen to charge up when exposed to the electron beam; thus distorting the SEM image. However, a quick scan of the coating surface was made to see if there was any evidence of whisker penetration through the coating. Later in the experiment, two specimens were vapor deposited with Gold (Au) to prevent charging. These specimens do not show any signs of tin whiskers penetrating through the coating.

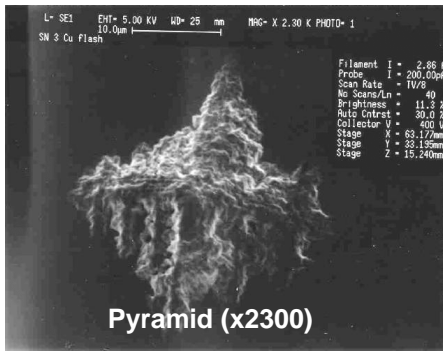
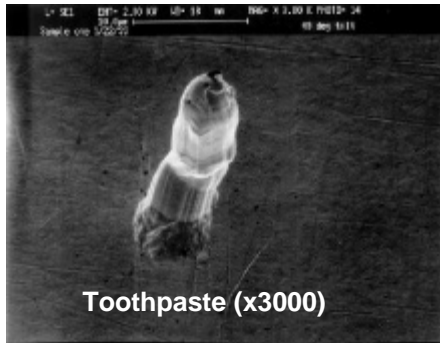
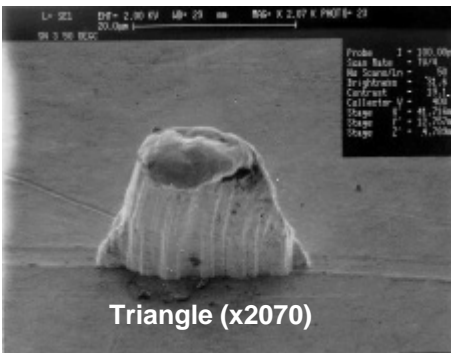
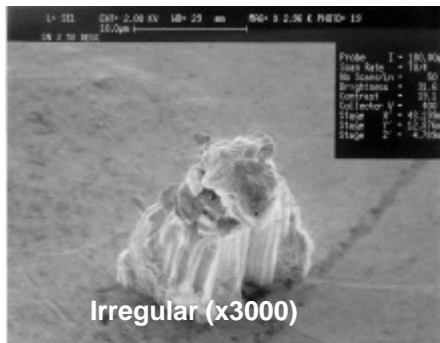
Figure 3. Four Typical Shapes of Tin Nodules

On the non-conformally coated side, nodules formed in various shapes, shown in Figure 3. Most of these nodules formed along surface scratches in the tin plating. These thin, tiny scratches are not the scratches that were made intentionally. In fact, relatively few whiskers were observed from the scratches that were made intentionally. Rather, the thin, tiny scratches, possibly resulting from abrasion by the paper within which the specimens were wrapped for shipping by the company that performed the electroplating process, promote almost 90% of the whisker formation observed.

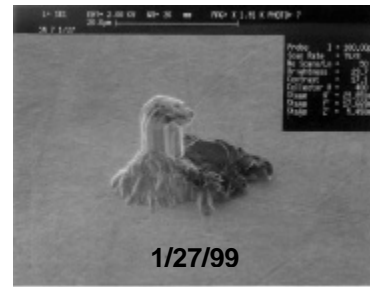
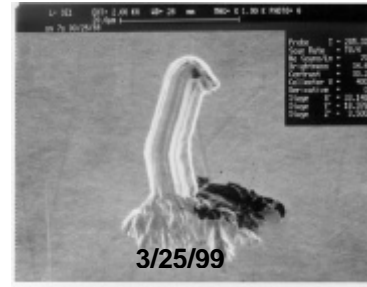
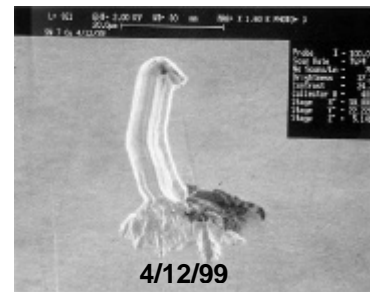
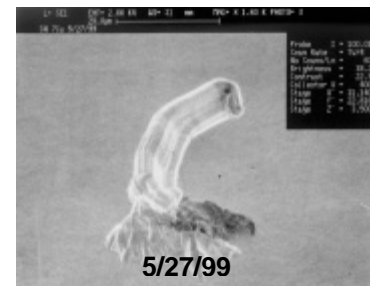
Figure 4. Nodule Pictures Taken Periodically (x1700)

Selected nodules were reinspected on a regular basis to determine the growth rate and to monitor the nodule formation process. Figure 4 depicts several stages of the formation of one specific tin whisker nodule.

This particular nodule had an average growth rate of 0.06 mm/year measured at 6 months, which can be compared to the reported growth rate value of 0.92 – 7.3 mm/year [4]. This nodule stopped growing after 6 months.

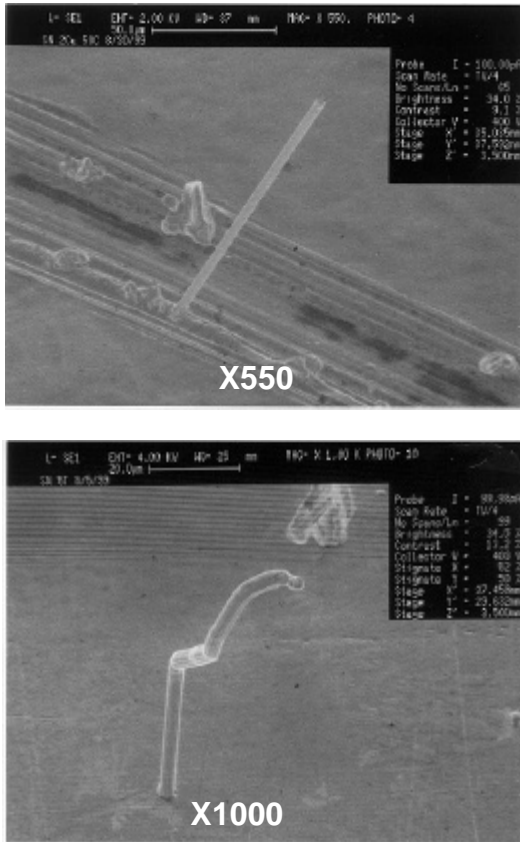
Figure 5. Tin Whiskers on the Non-conformally Coated Side

Some of these nodules are growing straight whiskers while other nodules grow whiskers with kinks (Figure 5).

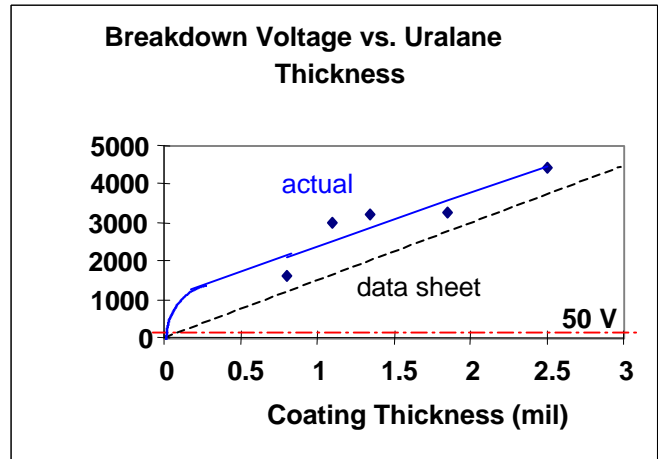
Figure 6. Breakdown Voltage from the Experiment

The dielectric strength of Uralane 5750 was reported to be 1500 V/mil by the manufacturer. However, this is for a uniform applied electric field. The field around the tip of the whisker is non-uniform, and so we performed some new breakdown tests. To simulate a tin whisker, a tungsten carbide probe tip (6 μm in diameter) was brought into contact with the Uralane conformal coat. The DC voltage was increased until dielectric breakdown was detected. The breakdown voltage from the experiment was measured to be higher than the value reported (see Figure 6). The Uralane coating would have to be extremely thin (less than 1/10 mil) for the breakdown voltage to even approach 50V, which was the

application voltage in the commercial satellite that failed.

Since the thickness of the Uralane coating on the NASA boards would be approximately 50 to 75 μm (2 to 3 mils), dielectric breakdown will not happen even when the whisker touches the surface of the coating, so long as the potential difference is less than a few thousand volts. Furthermore, the tin whisker will buckle when it pushes against the coating, rather than penetrate it. This is shown by comparing the buckling force with the force required to dimple the surface of the coating.

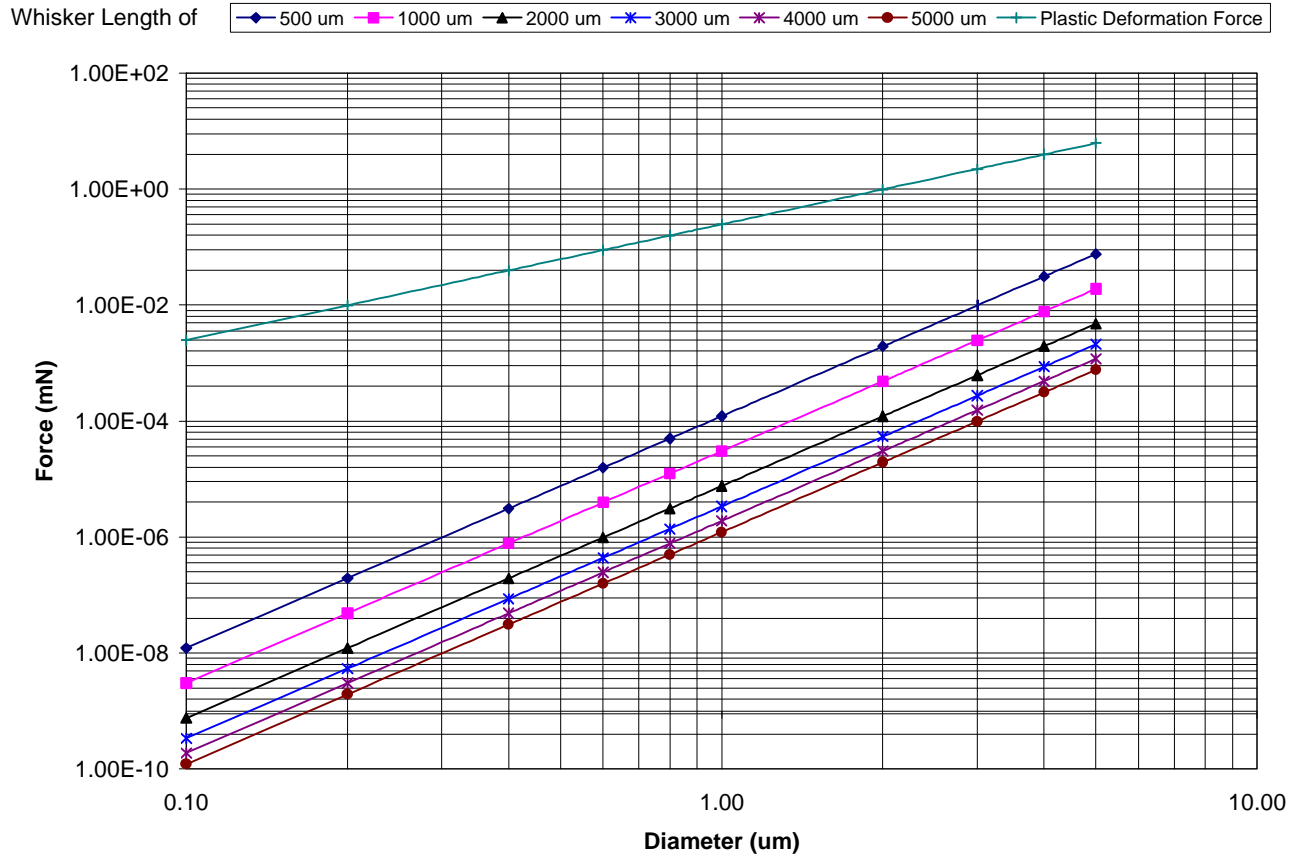
Figure 8. Tin Whisker Buckling Force Calculation

Figure 8 shows the buckling force of the tin whisker as a function of diameter and length.

Clearly, a long thin whisker would buckle more easily than a short, thick whisker. When the tin whisker tip is pushed against the Uralane, the coating will elastically dimple before it punctures.

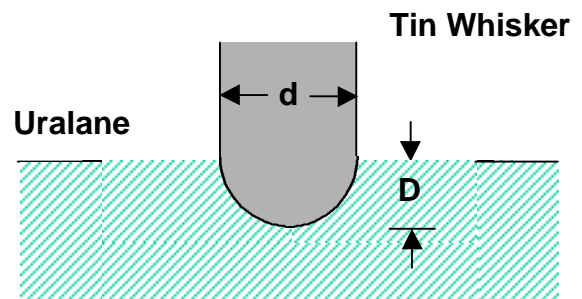
Figure 9. Diagram of Tin Whisker Contact against Uralane

The displacement of the surface due to the whisker pushing against the coating is:

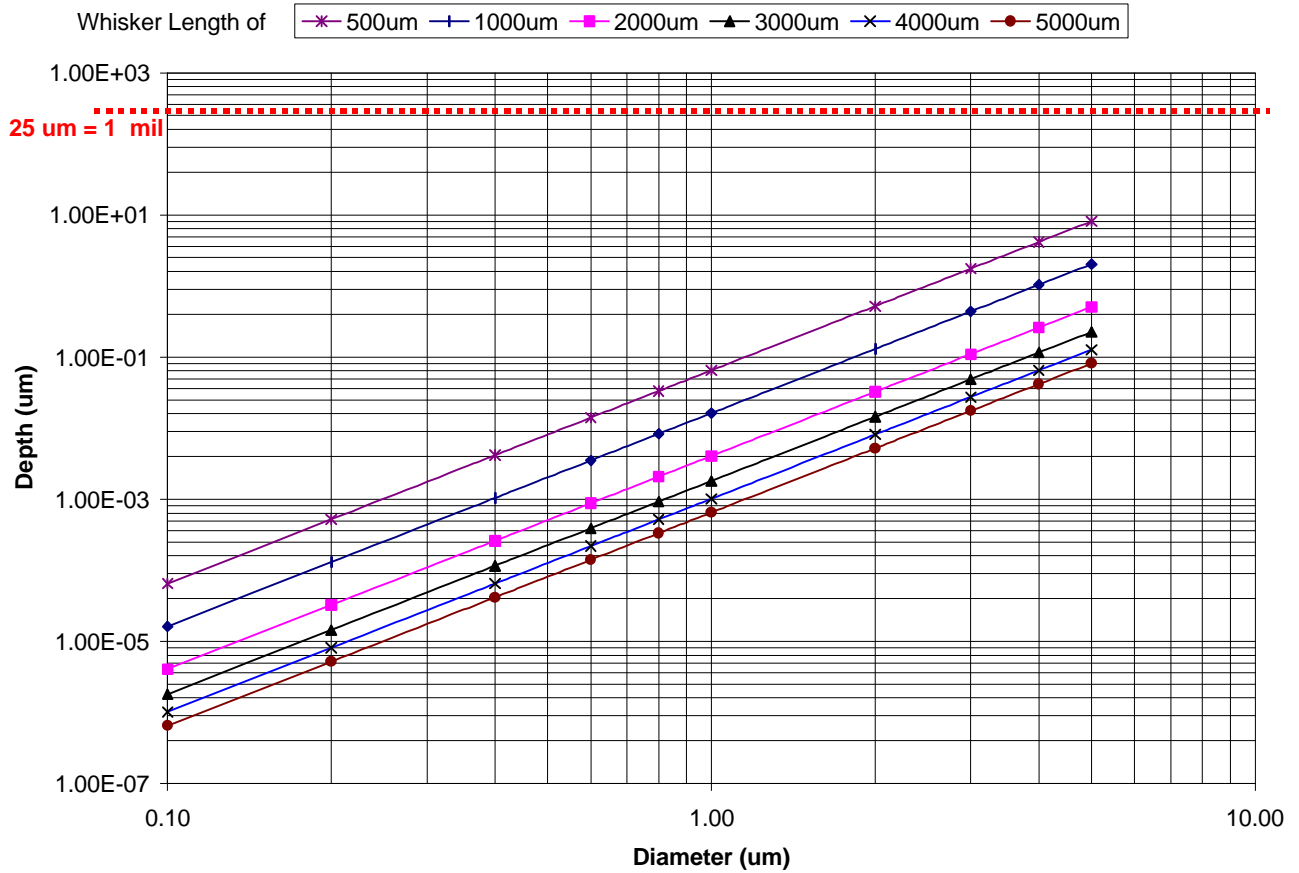
Figure 10. Penetration Depth before Buckling

According to Figure 10, even a short, thick whisker would make a dimple that is 2 orders of magnitude less than the minimum coating thickness of the specimen. Consequently, the tin whisker would only make a small dimple on the coating before buckling occurs.

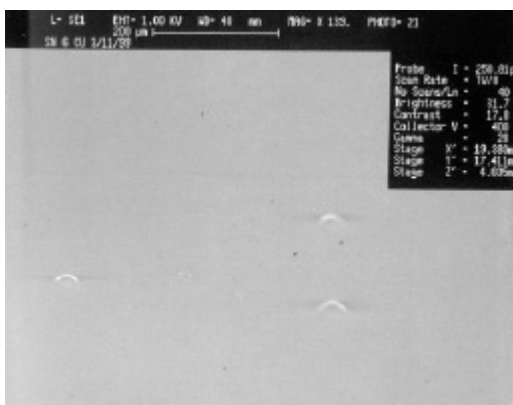
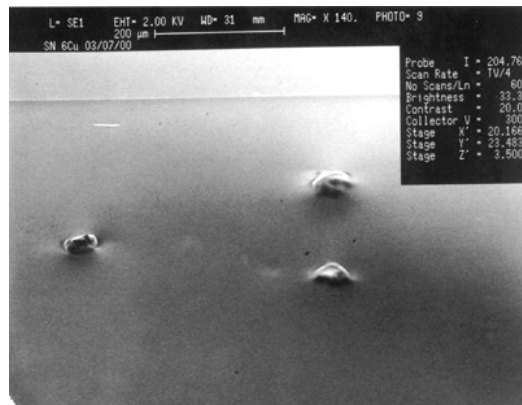
Figure 11. Whiskers Forming Under Coating

The latest observations indicate that tin whiskers under the conformal coat are pushing their way outward, causing dome shapes in the coating. As time progresses, these dome shapes are becoming larger and narrower at the top, which suggests that the whisker tips

are approaching the outer surface of the conformal coat. Figure 11 shows tin whiskers from the same location: Figure 11A is taken a year before Figure 11B. Similarly, figures 12A and 12B are photos of a whisker field taken 6 months apart.

A. Picture taken on 3/11/99 (x139)

B. Picture taken on 3/15/00 (x140)

Among 13 samples, only three specimens show these dome shapes. One is stored in the oven at 50 °C and two are kept at room temperature; one is copper flashed and the other is just pure tin over brass substrate.

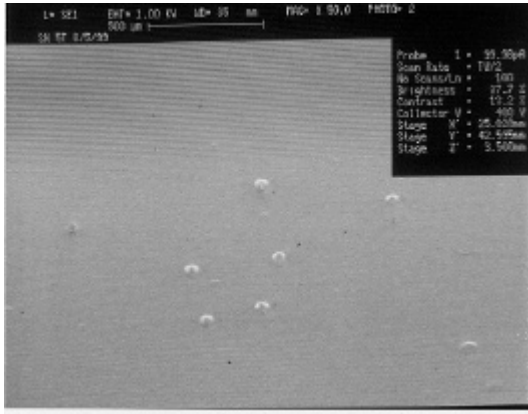
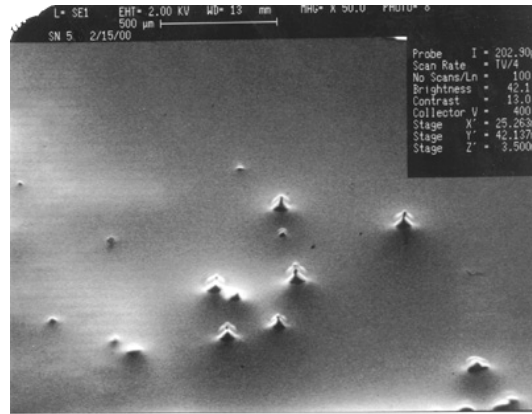
Figure 12. Whiskers Forming Under Coating

A. Picture taken on 8/5/99 (x50)

B. Picture taken on 3/15/00 (x50)

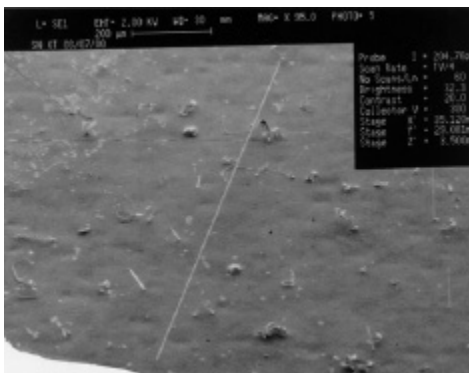
Figure 13. Tin Whiskers of the Non-conformally Coated Side (x95)

Figure 13 shows whiskers from a bare metal surface, without coating: some whiskers are growing faster than others. This one particular whisker grows at a rate of 0.64 mm/year. This whisker, which measured 0.8 mm in length (~31 mil) when the photo was taken, is long enough to cause short circuits between two leads having a standard 0.635 mm (25 mil) pitch.
